DEGRADATION PROCESSES IN SHIELD-CENTRING ELEMENTS OF SURGE ARRESTERS

This paper presents the results of testing samples of shield-centering elements from medium-voltage surge arresters. The elements were made of TSE glass textolite. The elements have been dismantled from different operated surge arresters, which were subjected to discharge currents (short-circuit currents) of different intensity and duration. The discharge currents led to degradation of the tested elements with various degrees of advancement. The degradation was investigated using microscopic methods and energy-dispersive X-ray spectroscopy (EDS). Changes in the content of elements of the surface of textolite materials – as the degradation progresses – were documented.

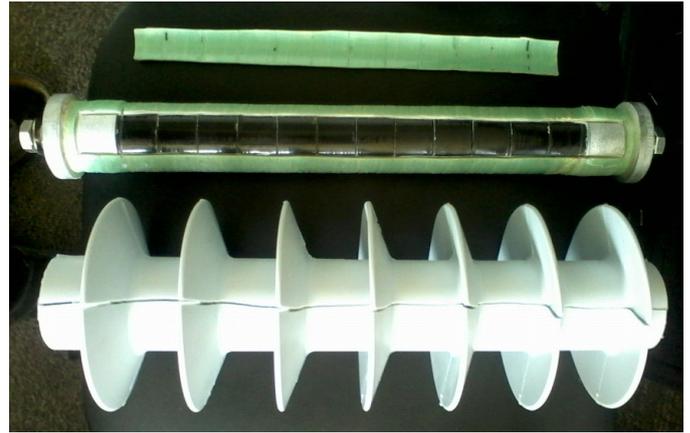
Fig. 1 shows not operated domestic (Polish) surge arrester whose shield-centring element has become a reference sample.

Fig. 1. Unexploited domestic MV surge arrester from 2018, after sectioning and removing the silicone elastomer cover – at the bottom. The cut-out fragment of the shield-centering element served as a reference sample – at the top. In the centre, the pile of varistors is visible

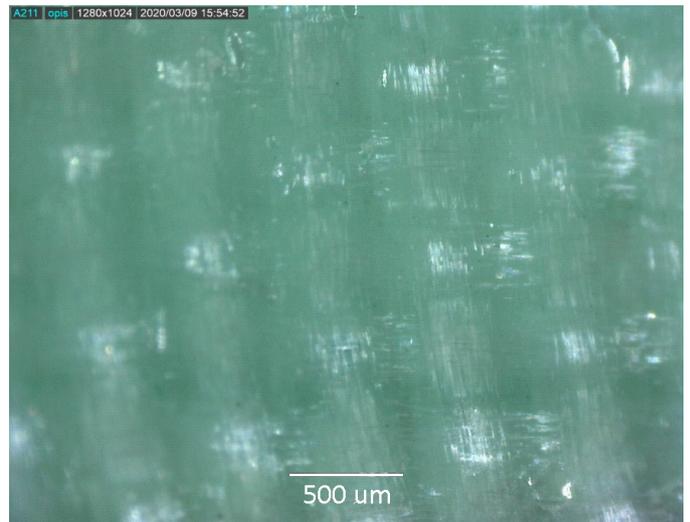
Fig. 2 shows the reference sample for the material under investigation. The fibres of the textile support were covered with a layer of transparent epoxy resin and were under the surface of the textolite. Fig. 3 shows the EDS test results of the surface of the initial material, for which the elemental composition was determined. The epoxy resin, the laminate binder present on the surface of the material, contained 76.6% carbon (C) and 23.4%

Fig. 2. OM image of the surface of textolite taken from an unexploited surge arrester, magnified 40 times. The textile weave made of fibreglass under the transparent resin layer can be seen

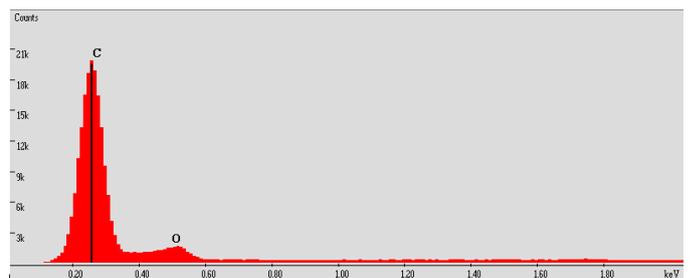
oxygen (O) by weight; the hydrogen (H) content was omitted – as it cannot be recorded using the EDS technique. The elements present in the fibreglass textile support – primarily silicon (Si) and calcium (Ca) – were not recorded, because they were covered with the organic resin layer.

Fig. 3. EDS spectrum obtained for the textolite surface from an unexploited surge arrester. Only carbon and oxygen, derived from the organic epoxy resin, were recorded

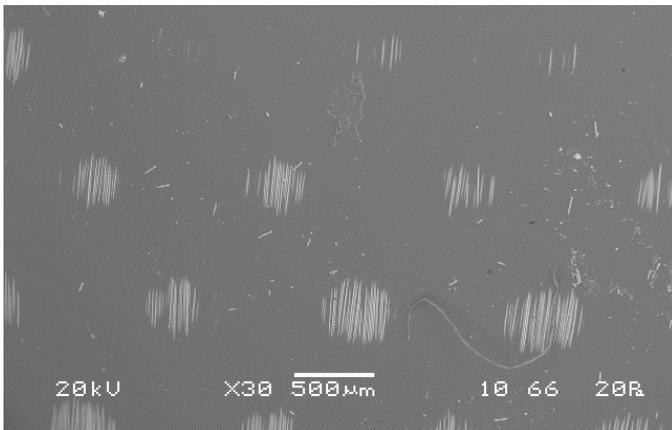
As a result of the flow of discharge currents and a local rise in temperature, the organic binder – epoxy resin – was melted and charred in some areas of the shield-centring elements. After the surface layer of resin has melted, fibre bundles from the textile support appeared on the surface of the material – Fig. 4. Fig. 5 presents the results of EDS analysis of the material surface in the area of slight degradation, with determined elementary composition. The surface of the material contained, besides carbon (78.0%) and oxygen (18.6%), also 1.6% of silicon and 1.0% of calcium, which came from these roving glass fibres on the surface of the laminate. Also minor admixtures of aluminium (Al) and magnesium (Mg) came from the glass. The degree of textolite degradation was not yet high and hence a small proportion of silicon and glass admixtures.

Fig. 4. SEM image of the textolite surface with weak degradation, magnified 30 times. Bundles of light-coloured roving fibres can be seen, which appeared on the surface of the laminate after the top layer of epoxy resin has melted

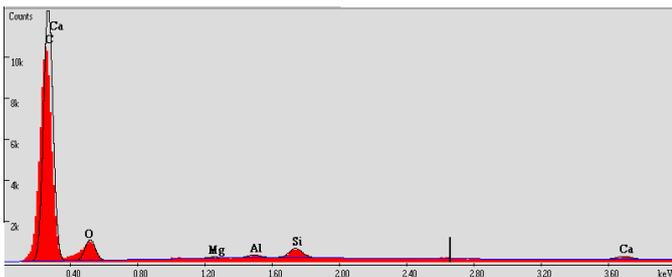
Fig. 5. EDS spectrum recorded for the textolite with slightly visible degradation in the form of a small content of elements present in the glass roving support (silicon, calcium, aluminium and magnesium)

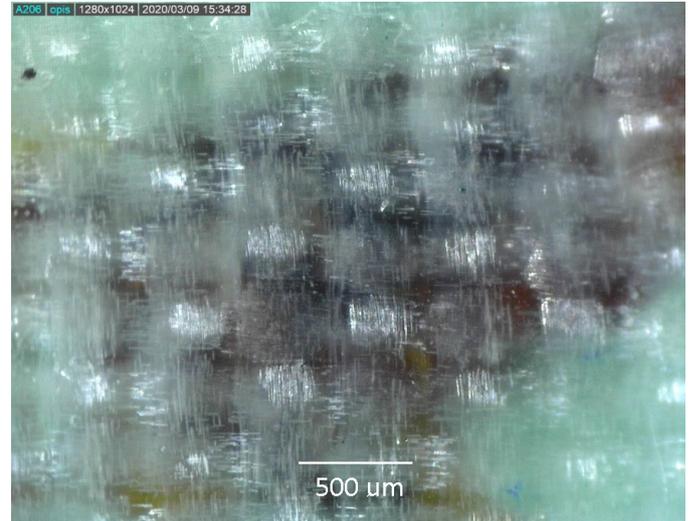
As the degradation effects progressed, more and more areas of charred epoxy resin were observed as a result of the discharge currents – Fig. 6. These areas kept increasing and the degree of charring of the organic phase intensified. Even where the resin was not yet heavily carbonised, its outer layer was melted to such an extent that the textile support was more and more noticeable on the surface. The fibre bundles can be seen particularly well in the SEM images – Fig. 7.

Fig. 6. OM image of the surface of the textolite with visible degradation, magnified 40 times. A part of the sample is clearly charred, and the shining fibre bundles of the roving support emerged on the surface after melting of the top resin layer

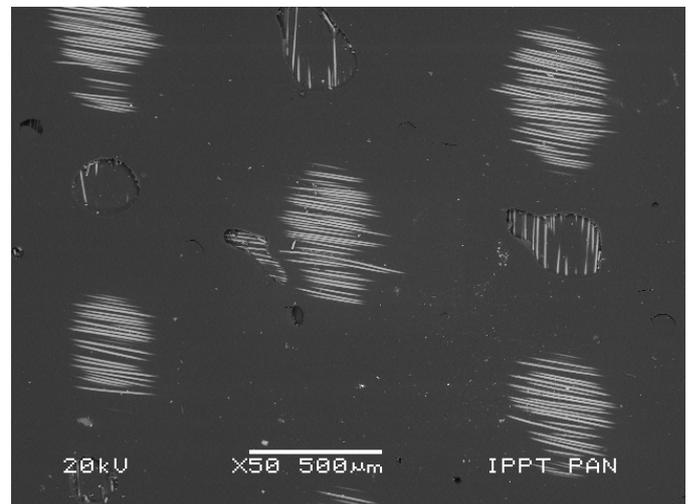
Fig. 7. SEM image of the textolite surface with advanced degradation, magnified 50 times. In the top layer of the material the resin is melted to a large extent. Bundles of bright roving fibres emerge from under it. There are also melted indentations in the resin

EDS analysis of the textolite with advanced degradation – Figs 6 and 7 – indicated an already pronounced content of the glass roving in the elemental composition of the material surface. The content of carbon (74.1%) and oxygen (16.9%) were reduced by several percent. This proves a significant loss of

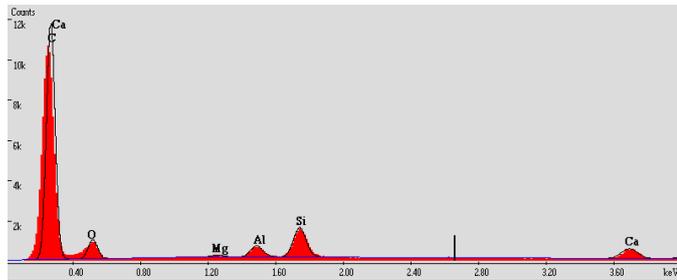
the organic phase – epoxy resin in the top layer of the textolite. At the same time, the amount of elements present in the glass increased: silicon to 4.6%, calcium to 2.9% and aluminium to 1.4% – Fig. 8. In total, they accounted for about 9% by weight of the laminate surface, excluding the oxygen part. The temperature rise resulting from the discharge currents, in some areas of the shield-centring elements, must therefore have been large, exceeding 200°C.

Fig. 8. EDS spectrum recorded for the textolite with advanced degradation effect. Significant proportion of elements present in the glass textile support: silicon, calcium and aluminium is visible

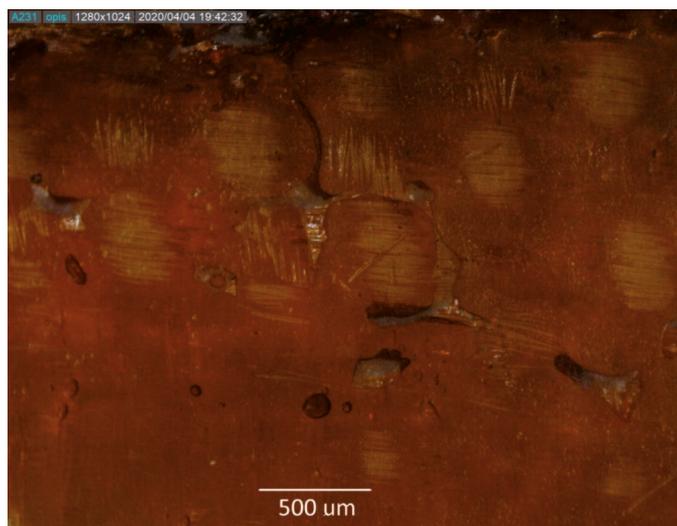
As a result of the flow, especially over a long period of time, of strong discharge currents, there must have been a large local growth in temperature – even reaching 300°C. As a consequence, the degradation of the organic epoxy resin increased in some areas of the shield-centring elements. Fig. 9 shows an OM image of the textolite from an operated surge arrester, where the charring of the resin has reached a high level. This is evidenced by the change in colour of the textolite to much darker. Fragments of the material showed a high variation in the degree of degradation. The temperature was then only high in specific areas of the shield-centring elements. In these areas, strong or even very strong degradation of the laminate effects were observed.

Fig. 9. OM image of the textolite surface with strong degradation, magnified 40 times. A fragment of the sample material has been considerably charred – the colour of the textolite has changed. Bright fibre bundles of the roving textile support can be seen. When the top layer of resin melted, these were found on the surface of the laminate

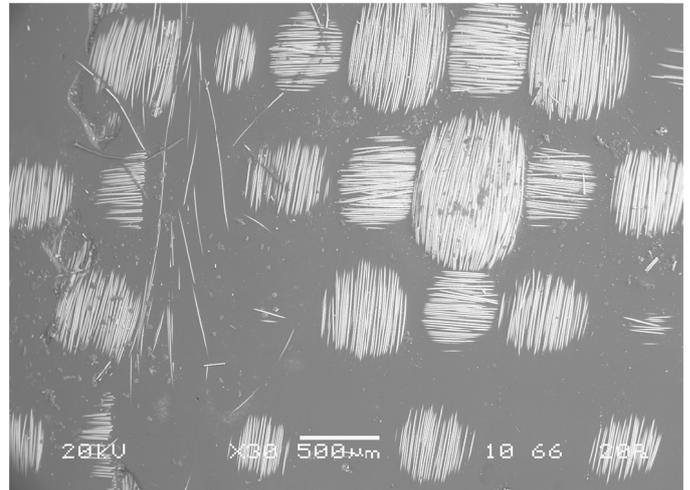
A number of flows of high discharge currents led to significant melting of the organic epoxy resin, especially of its top layer partial charring and even burning. As a result, numerous fibre bundles from the roving textile support are clearly visible in the SEM images – Fig. 10. Consequently, elements from the glass are a significant component in the elemental composition of the surface layer of the material.

Fig. 10. SEM image of the surface of the textolite with very strong degradation, magnified 30 times. The resin on the top layer has been considerably melted. Numerous bright bundles are visible on the surface, as well as individual glass fibres with areas of damaged roving

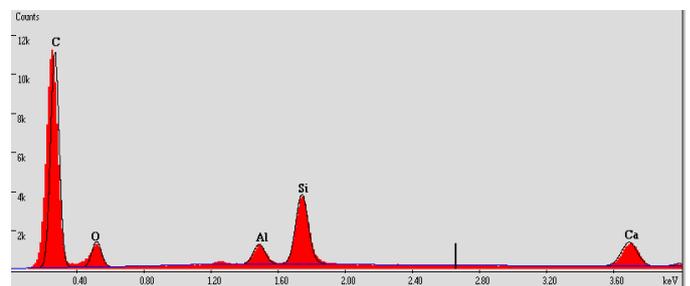
Fig. 11 shows EDS analysis of a very heavily degraded surface of the textolite. The carbon content remained at 68.0%, compared to the original value of 76.6%. The amount of elements present in the glass increased significantly: silicon to 8.4%, calcium to 5.5% and aluminium to 2.6% – a total of 16.5% (excluding oxygen). The epoxy resin from the surface layer of the laminate has melted and has been partially charred and burnt.

Fig. 11. EDS spectrum recorded for the textolite with very strong degradation. There is a significant proportion of elements present in the glass roving: silicon, calcium and aluminium. Oxygen is present in both – organic and inorganic phases

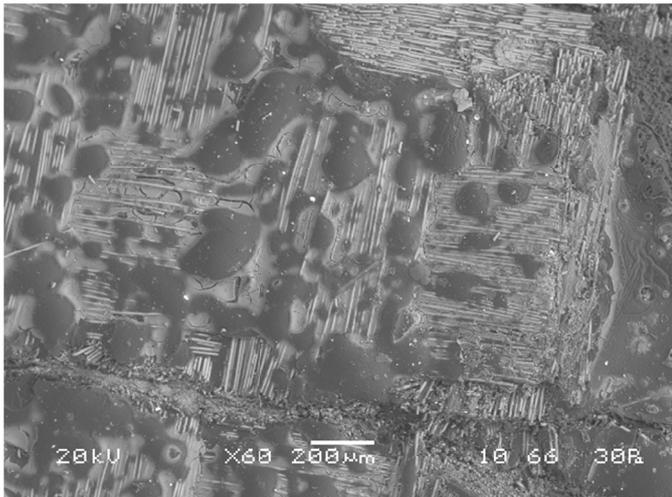
High local temperature rise led to very strong degradation of the laminate in some areas of the shield-centring elements of surge arresters. In extreme cases, the organic epoxy resin melted and was charred, cracked or even burnt out. An example of very

severe damage to the textolite structure and exposure of the textile roving support is shown in Fig. 12.

Fig. 12. SEM image of the textolite surface with very strong degradation, magnified 60 times. The resin on the top layer of the material has largely melted; it is charred and burnt. As a result, the roving support has become visible
