A. ZIEWIEC*, J. CZECH**, E. TASAK*

WELDED JOINT CRACKING IN MARTENSITIC STAINLESS STEEL PRECIPITATION-STRENGTHENED WITH COPPER

Problem of welded joint cracking in the HAZ of Cu strengthened 17-4PH grade precipitation hardening martensitic stainless steel is presented. Hypothesis concerning hydrogen embrittlement origin of the cracks is opposed. It was concluded that the cracks located in the high-temperature zone of the HAZ exhibit characteristics of hot cracks which originated as a result of steel embrittlement in the presence of Cu rich liquid phase. The mechanism of steel surface enrichment in Cu is proposed. Practical methods of cracks elimination are presented.

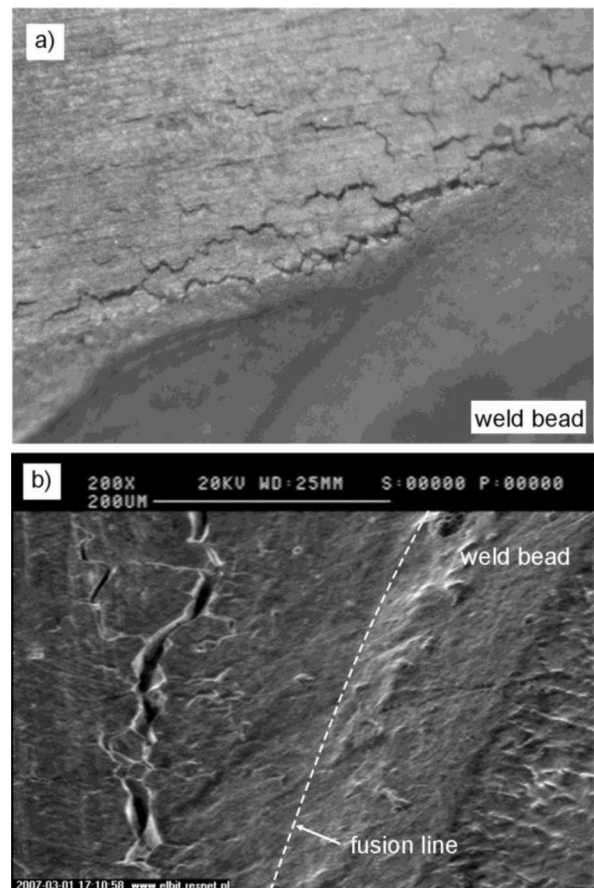
However, both FPI and visual detection techniques were limited by local oxide scale in the affected HAZ. The oxide scale prevented visual observation of the metal surface beneath the oxide and the mechanical removal of the oxide usually involved removal of metal to a thickness exceeding the average depth of the micro cracks. The oxide scale itself was also often cracked or delaminated from the base material in some areas: features which sometimes retained penetrant and resulted in false indications. For these reasons the most reliable technique of micro cracks detection was by examination of metallographic cross sections of areas identified by stereoscope microscope (using up to 63x magnification). In order to characterise the cracks and investigate their origin, metallographic sections were prepared and examined with both: a light microscope and a Scanning Electron Microscope (SEM). Search results for possible preventative measures were outlined. Typical appearance of the observed defects is presented in Fig. 2.

Fig. 2. Cracks in HAZ of 17-4PH steel welded with GTAW method a) cracks observed by stereoscope microscope, b) cracks observed by SEM
