## THE DEFECTS OF OXIDE LAYERS FORMED ON 10CrMo9-10 STEEL OPERATED FOR 200,000 HOURS AT AN ELEVATED TEMPERATURE

The paper contains results of studies into the formation of oxide layers on 10CrMo9-10 (10H2M) steel long-term operated at an elevated temperature ( $T = 545^{\circ}\text{C}$ ,  $t = 200,000\text{h}$ ). The oxide layer was studied on a surface and a cross-section at the inner and outer surface of the tube wall on the outlet both on the fire and counter-fire side of the tube wall surface.

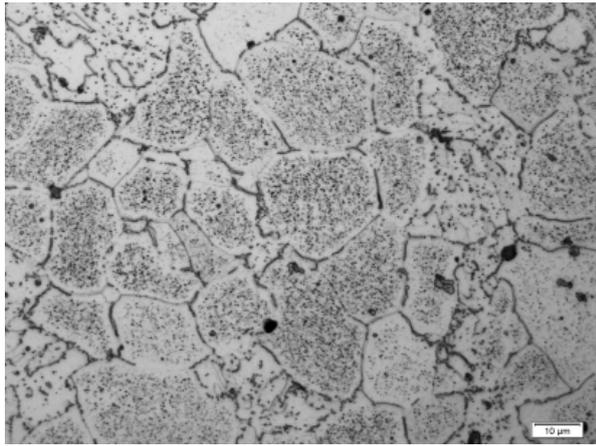
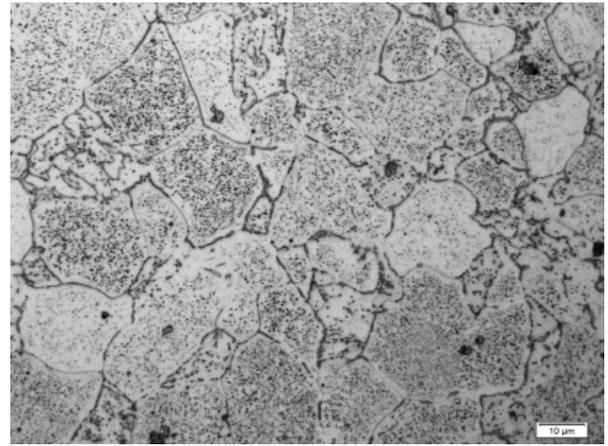
After a long-term operation ( $T = 545^{\circ}\text{C}$ ,  $t = 200,000\text{h}$ ) 10CrMo9-10 steel shows degradation of bainitic-ferritic structure. The extent of degradation on the fire side is much higher than on the counter-fire side, which is presented in Fig. 1. A substantial depletion of boundary areas in carbide precipitates is visible on the fire side. Instead, in both cases carbide precipitates create ‘chains’ along boundaries, in certain places there are also cases of etching around sulphide precipitates and sporadic creep micropores on the

Fig. 1. Microstructure of 10CrMo9-10 steel operated for 200,000 hours at the temperature of  $545^{\circ}\text{C}$ , LM: (a) fire wall, (b) opposite fire wall

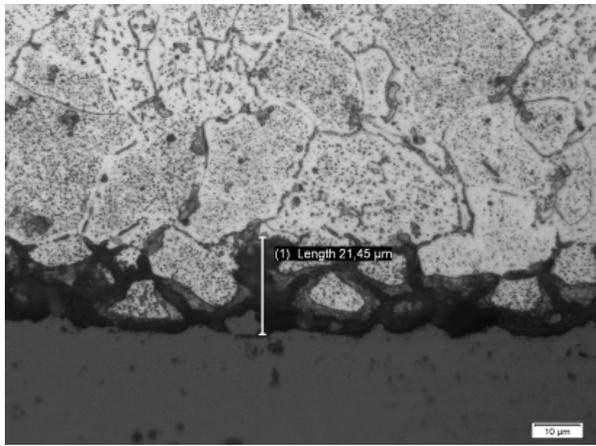
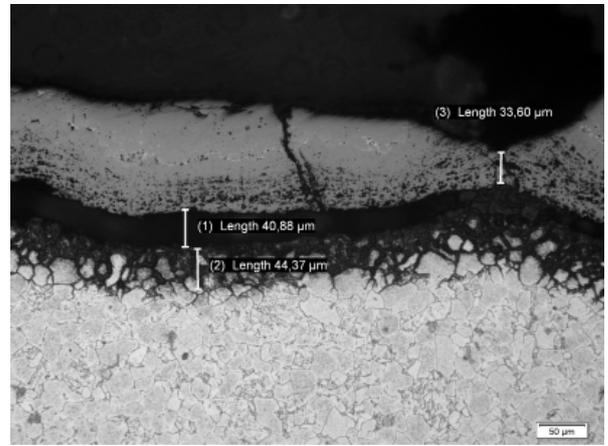
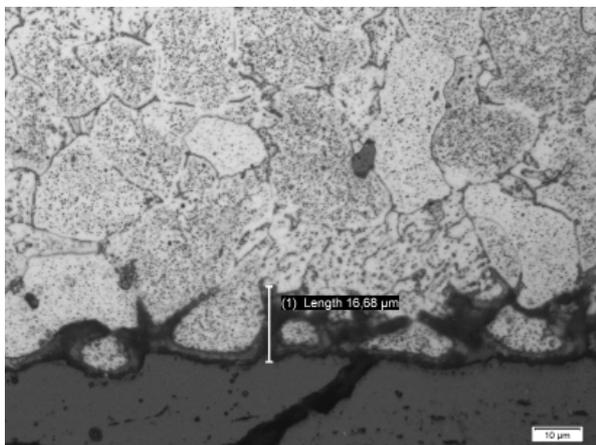
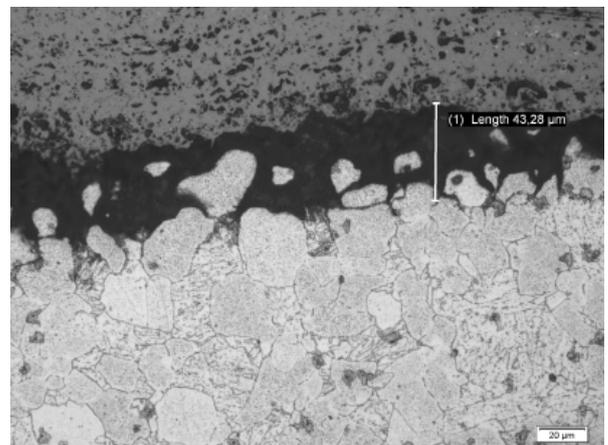
fire side. Corrosion on the grain boundaries also exists, both on the fire and counter-fire side, which is presented in Fig. 2. Such corrosion together with crevice corrosion to the largest extent occurs at the outside wall on the fire side, reaching  $84\ \mu\text{m}$  in depth. While on the counter-fire side at the outside wall corrosion exists on the grain boundaries to the depth of  $43\ \mu\text{m}$ . At the inside wall, on the fire and counter-fire side, corrosion on the grain boundaries exists to the depth of  $21\ \mu\text{m}$  and  $17\ \mu\text{m}$ , respectively.

Fig. 2. Corrosion on the grain boundaries at: (a) inner surface – fire wall, (b) outer surface – fire wall, (c) inner surface – opposite fire wall, (d) outer surface – opposite fire wall

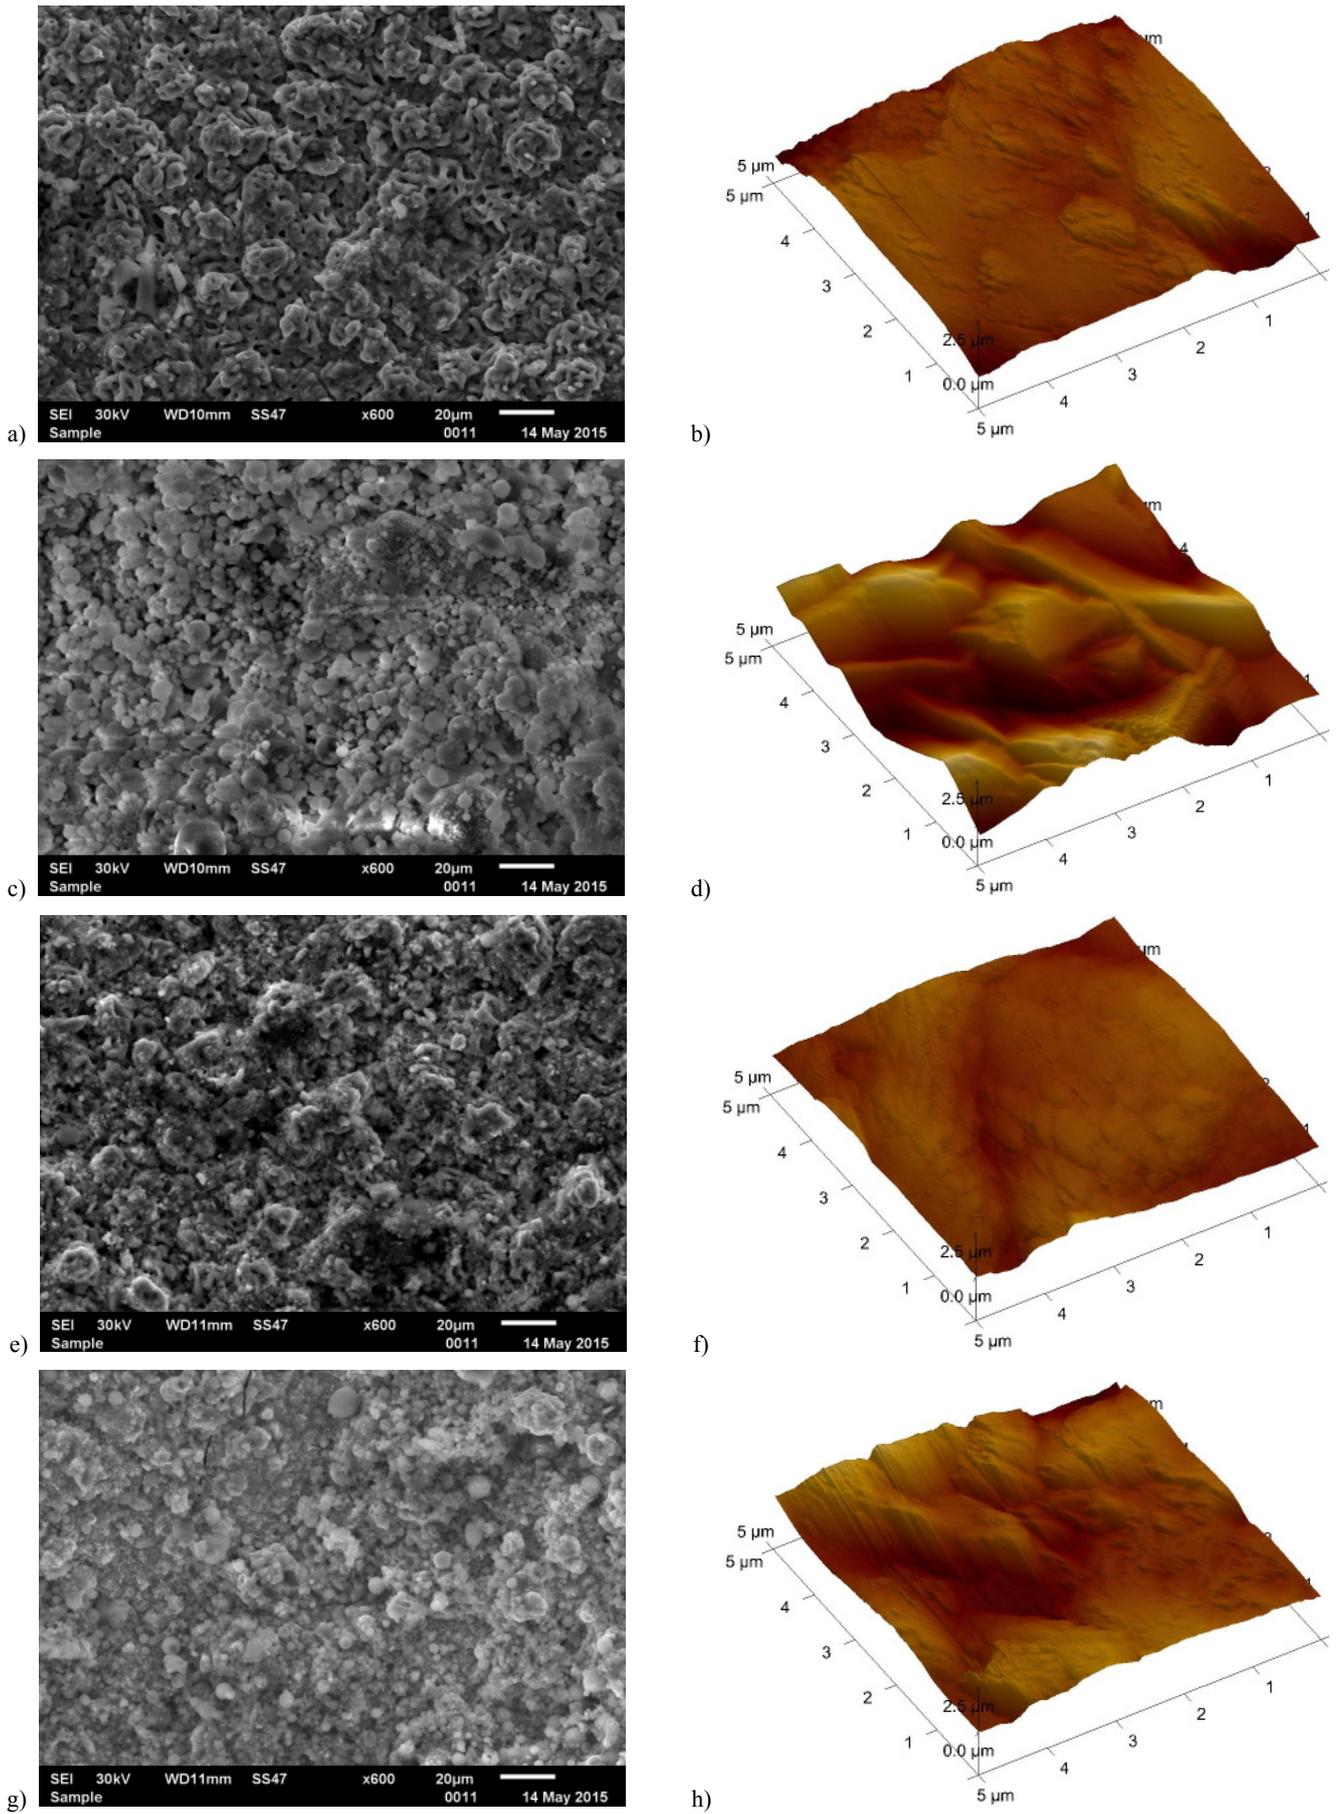
Fig. 3 presents results of surface microscopic studies, where a greater degradation on the outside of tube wall is visible.

Fig. 3. Oxides formed on 10CrMo9-10 steel operated at 545°C during 200,000 hours: (a) inner surface – fire wall, SEM; (b) inner surface – fire wall, AFM; (c) outer surface – fire wall, SEM; (d) outer surface – fire wall, AFM; (e) inner surface – opposite fire wall, SEM; (f) inner surface – opposite fire wall, AFM; (g) outer surface – opposite fire wall, SEM; (h) outer surface – opposite fire wall, AFM

Fig. 3d and h shows spalling of individual deposit/oxide layers on the outside. In the case of fire side, both on the inside and outside, a larger degree of surface development was observed (Fig. 3a and c).

The surface topography studies (Figs. b, d, f, h and Table 1) have shown that the largest degree of surface development occurred on the outside surface on the fire side, where Ra and Rmax were 406 nm and 2790 nm, respectively.

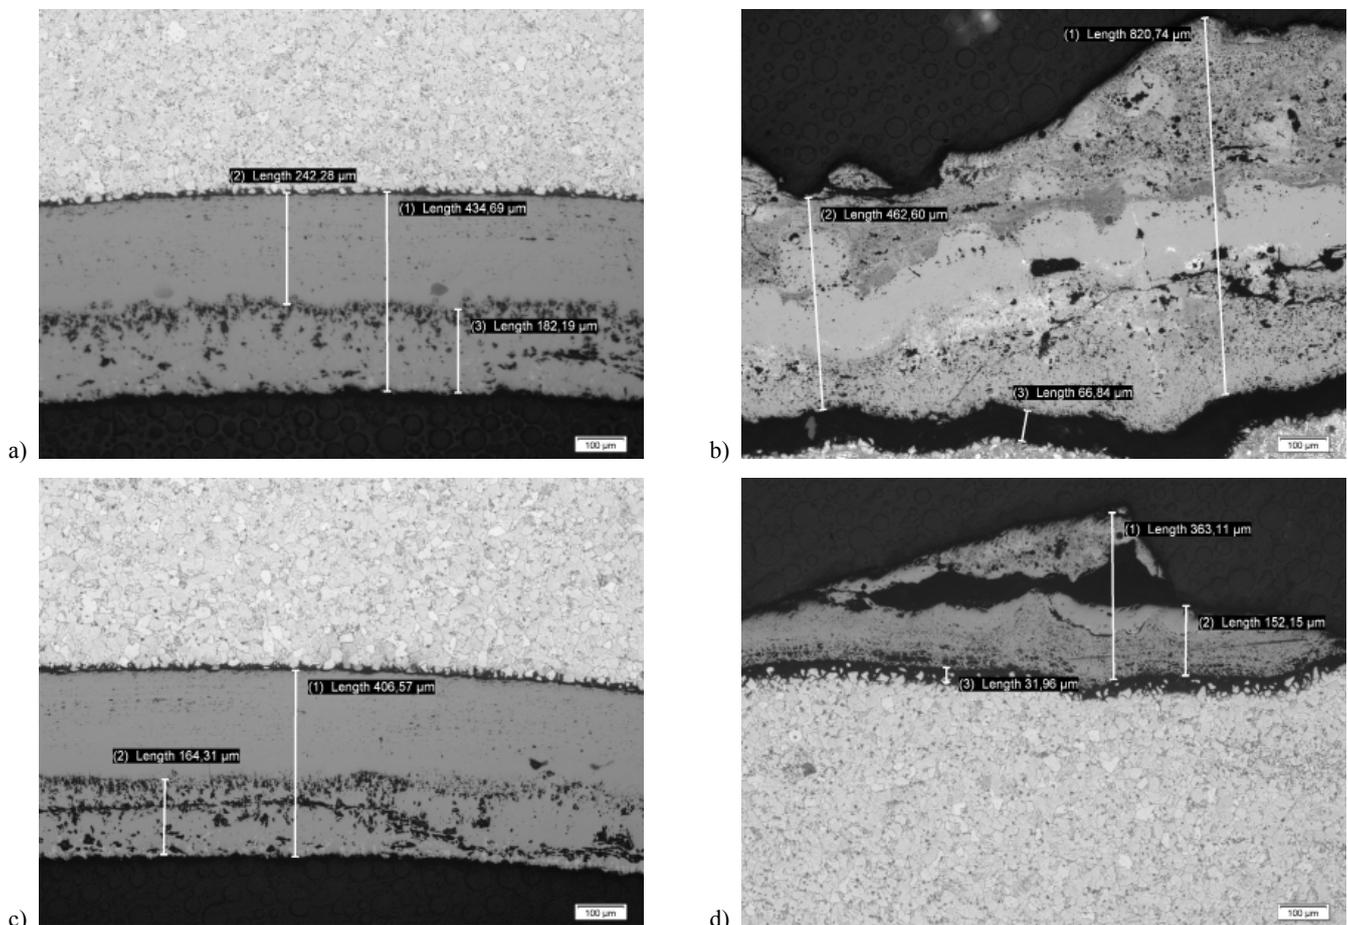
The oxides layer thickness together with deposits on the fire side was 435  $\mu\text{m}$  and 820  $\mu\text{m}$  on the flowing medium and

flue gas side, respectively (Fig. 4a, b). For the counter-fire side on the inside the oxides layer thickness is smaller by 30  $\mu\text{m}$ , while on the outside by as many as 460  $\mu\text{m}$  (Fig. 4c, d). The layer formed on the fire outside shows high degradation, which is presented in Fig. 5b, where a surface after spalling of a thick deposit layer is visible. In addition, a very large fissure reaching the depth of 235  $\mu\text{m}$  may be noticed. Instead, on the inside only local spalling in the oxides layer may be observed directly on the flowing medium side (Fig. 5a).

Fig. 4. The thickness of oxides layer formed on the steel examined, LM: (a) inner surface – fire wall, (b) outer surface – fire wall, (c) inner surface – opposite fire wall, (d) outer surface – opposite fire wall

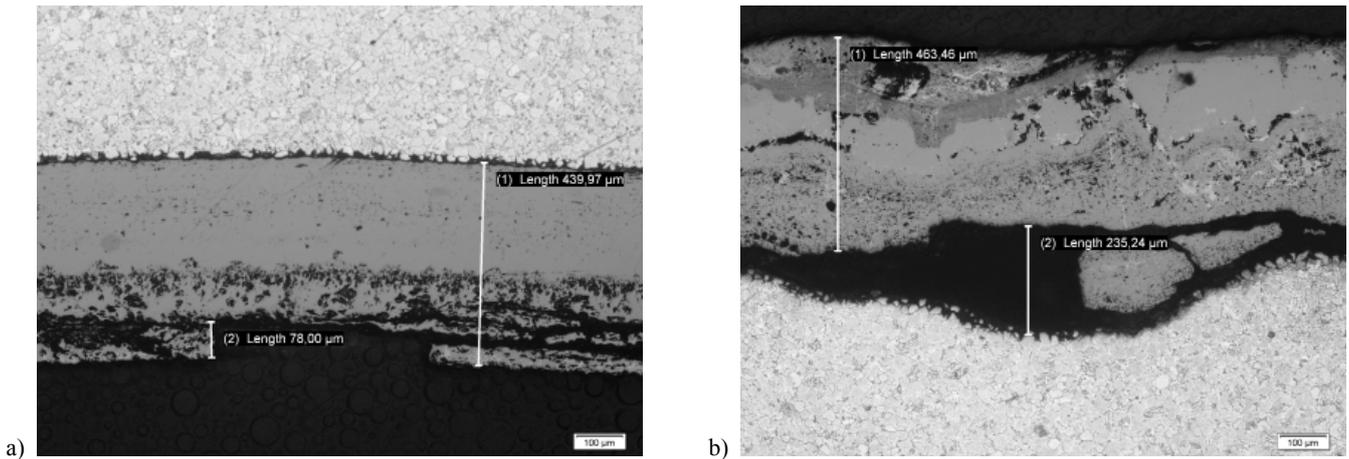
Fig. 5. The damage of oxide layer; cross section: (a) inner surface – fire wall, (b) outer surface – fire wall

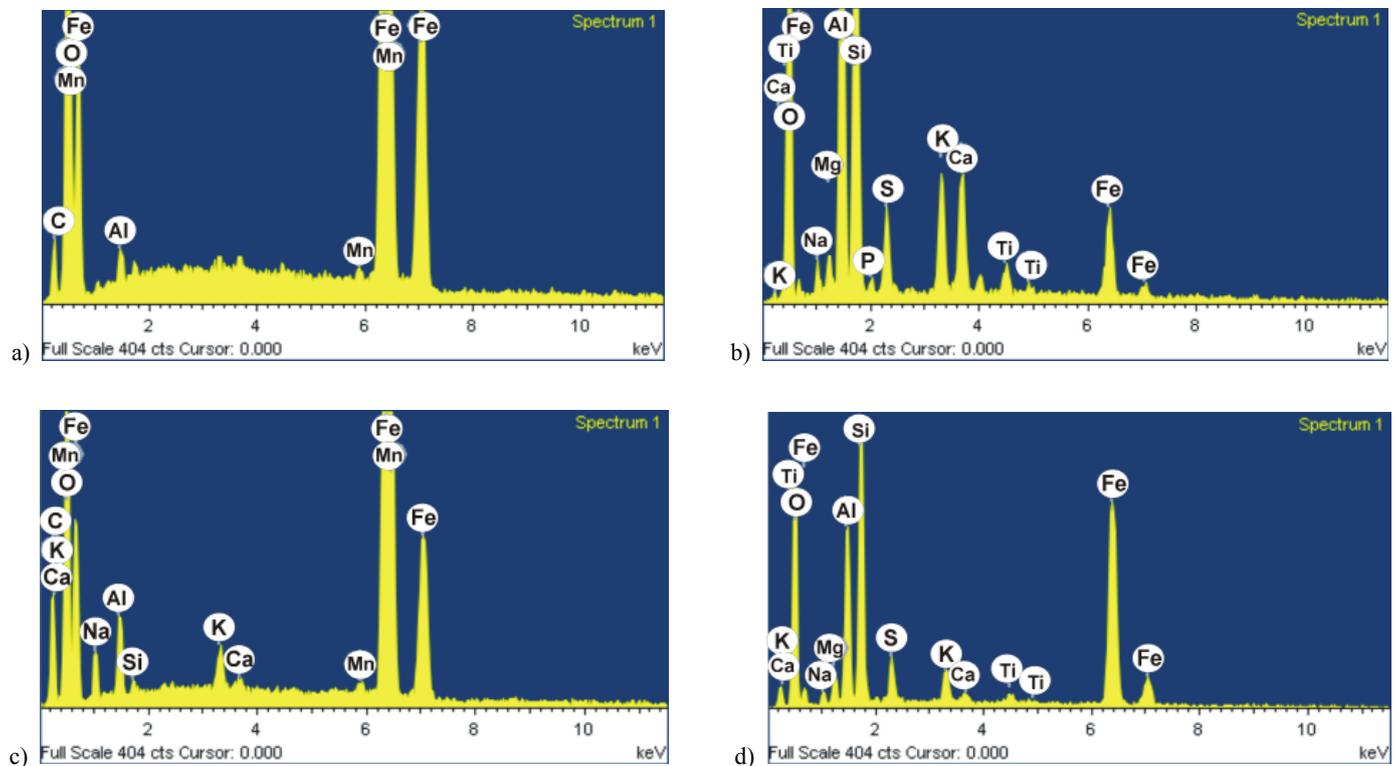
Performed EDS analysis of chemical composition (Fig. 6) combined with X-ray phase analysis (Fig. 7) has shown that oxides occur on the inside surface of tube. Based on DHN PDS and PDF4+2009 crystallographic database it has been found that the forming oxides are:  $\text{Fe}_2\text{O}_3$  and  $\text{Fe}_3\text{O}_4$  in accordance with the catalogue card numbers: 01-079-0007, 01-089-0951, respectively. In the case of the outside surface of tube from opposite fire wall apart from the aforementioned compounds also Al, Si, K, Ca, Ti, Mg, Na and S based compounds exist, such as:  $\text{Al}_2\text{SiO}_5$ . The other elements, such as K, Ca, Ti, Mg, Na, occur in small amounts. Instead, directly on the fire outside only  $\text{Al}_2\text{SiO}_5$  exists and small amounts of K, P, S, Ca, Ti, Mg and Fe. After removing the external deposit layer on the outside and repeating the XRD analysis it has been shown that the forming oxide layer is built of  $\text{Fe}_2\text{O}_3$  and  $\text{Fe}_3\text{O}_4$  (Fig. 8).

Fig. 6. EDS point microanalysis: (a) inner surface – fire wall, (b) outer surface – fire wall, (c) inner surface – opposite fire wall, (d) outer surface – opposite fire wall

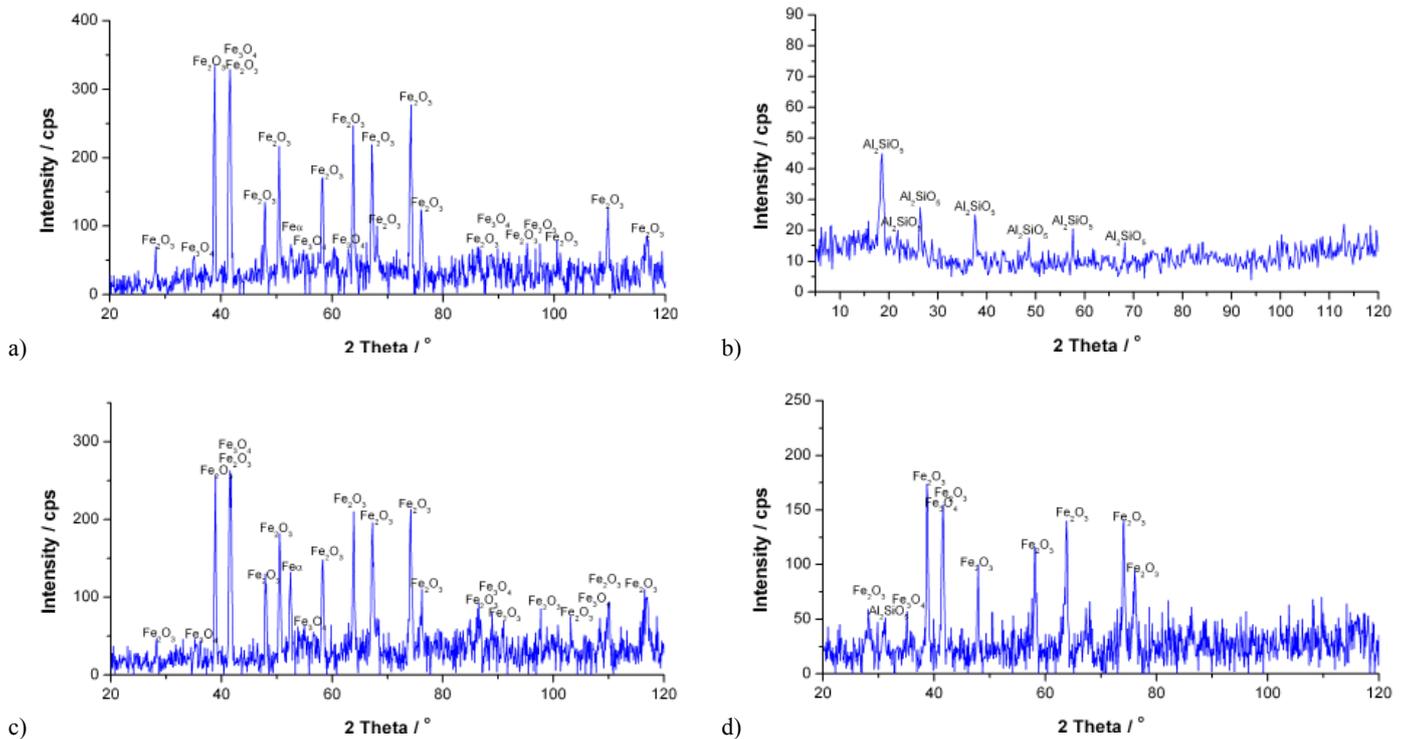
Fig. 7. Diffraction pattern of oxide layers obtained using the XRD technique: (a) inner surface – fire wall, (b) outer surface – fire wall, (c) inner surface – opposite fire wall, (d) outer surface – opposite fire wall

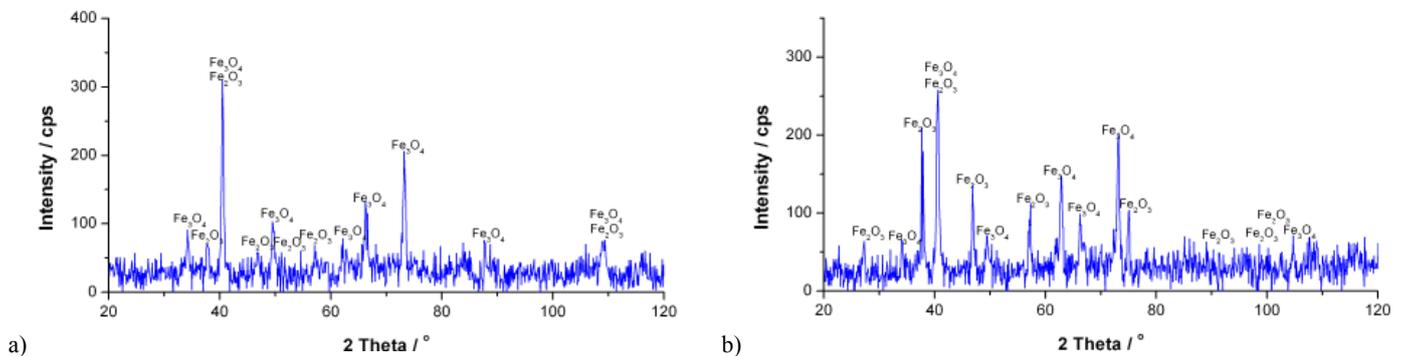
Fig. 8. Diffraction pattern of oxide layers after polishing obtained using the XRD technique: (a) outer surface – fire wall, (b) outer surface – opposite fire wall
