INVESTIGATION OF STRESS CORROSION CRACKING IN MAGNESIUM ALLOYS BY QUANTITATIVE FRACTOGRAPHY METHODS

The article shows that the use of quantitative fracture description may lead to significant progress in research on the phenomenon of stress corrosion cracking of the WE43 magnesium alloy. Tests were carried out on samples in air, and after hydrogenation in 0.1 M Na₂SO₄ with cathodic polarization. Fracture surfaces were analyzed after different variants of the Slow Strain Rate Test. It was demonstrated that the parameters for quantitative evaluation of fracture surface microcracks can be closely linked with the susceptibility of the WE43 magnesium alloy operating under complex state of the mechanical load in corrosive environments. The final result of the study was the determination of the quantitative relationship between Slow Strain Rate Test parameters, the mechanical properties, and the parameters of the quantitative evaluation of fracture surface (microcracks).

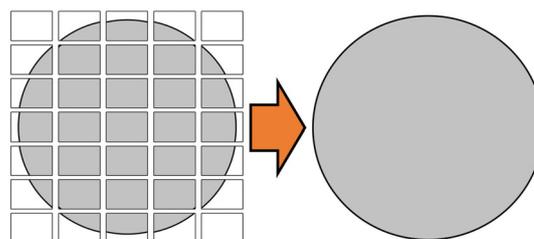
- 1) the whole fracture surface was taken into consideration – especially evaluation of cracks on fracture surface as an important feature;
- 2) input images for quantitative fractography were high resolution (HR) fracture micrographs, obtained by merging together of many SEM images involving the whole fracture surface (Fig. 1). Application of HR images of the whole fracture surface allowed to detect of all small cracks;

Fig. 1. Scheme of HR image preparation for quantitative fractography

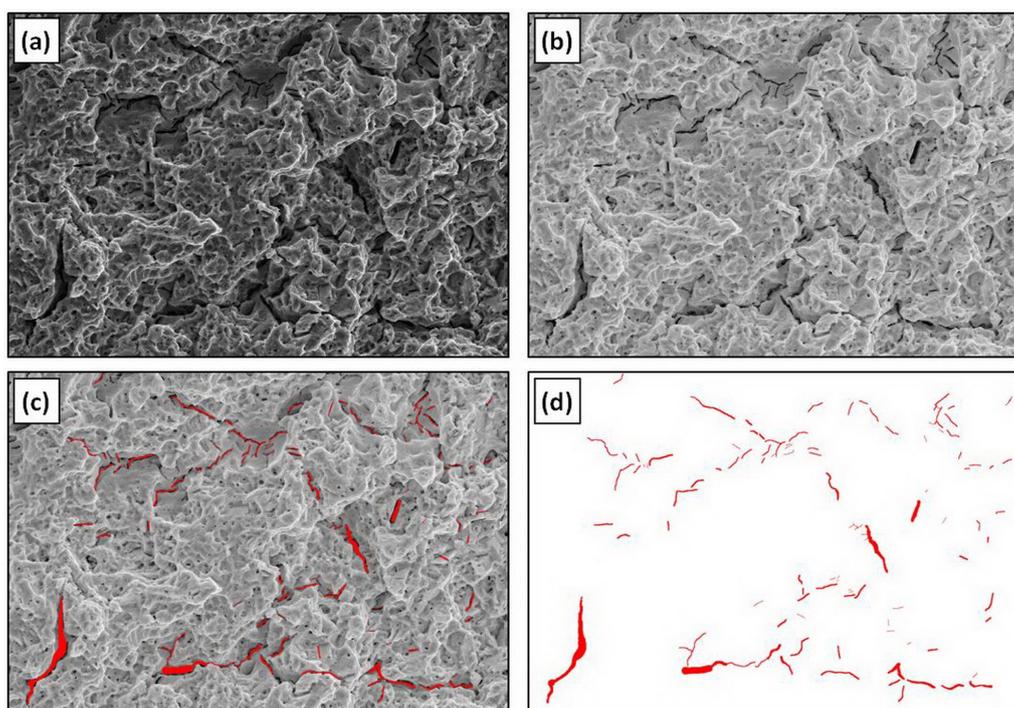
- 3) cracks detection of the fracture surface. Due to very low diversification of gray scale level between cracks and remain fracture area, an automatic detection was not possible. A manual detection using the GIMP software was applied and it consists of four stages: (i) a reading in of HR image to the software; (ii) correction of brightness and contrast in order to emphasize of cracks on fracture surface; (iii) a manual detection of cracks on fracture surface; (iv) saving a binary image of cracks. Each stage of mentioned procedure is shown in Fig. 2.

Fig. 2. Procedure of manual cracks detection on the fracture image: (a) reading in an image intended for analysis; (b) brightness and contrast correction for cracks revealing; (c) manual cracks detection ; (d) saving the binary image

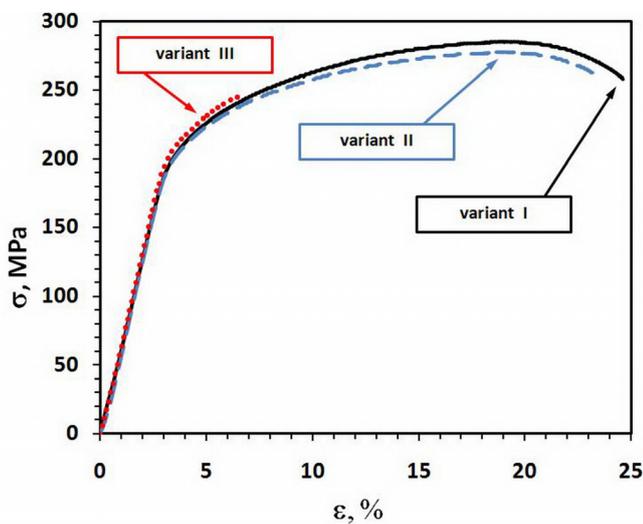
Evaluation of simultaneous interaction of mechanical load and corrosive environment on WE43 alloy was performed on the basis of SSRT. Results of these investigation were shown in Fig. 3 and in Table 1.

Fig. 3. Tensile curves for WE43 alloy obtained from SSRT

Obtained results reveal that mechanical properties strongly decreased in case of the 3rd variant of SSRT in comparison to the 1st variant (strain in air): UTS decreased from 283 MPa to 244 MPa, unit elongation decreased from 24.6% to 7% and necking decreased from 39.2% to 11.6%. Time to rupture shortened

about three times in comparison to SSRT in air (from 73.1 h to 22.2 h). In case of the 2nd variant of SSRT only the necking decreased from 39.2% to 31.1% in comparison to 1st variant. Other parameters (ϵ , UTS, t) were comparable to the 1st variant of SSRT.

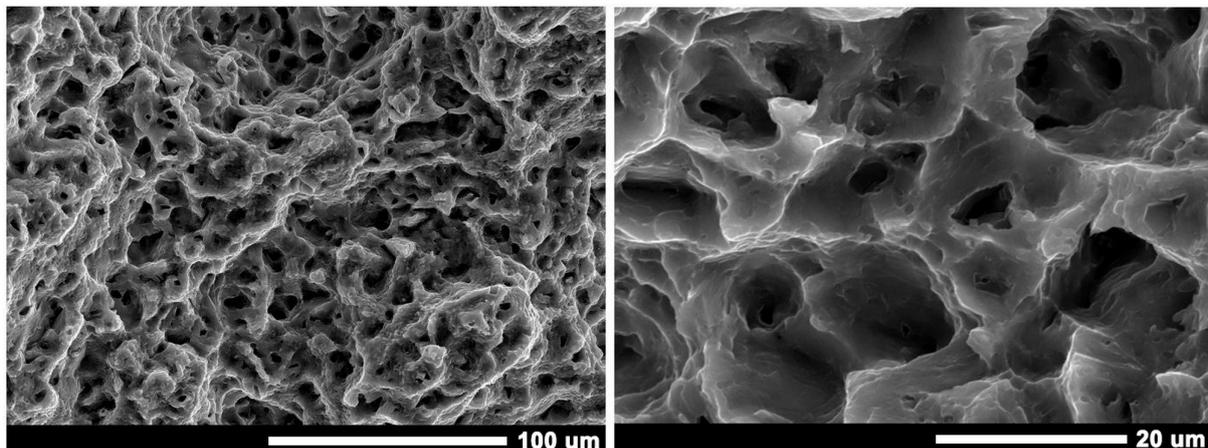
Comparison of SEM micrographs after 1st and 2nd variants of SSRT reveal significant changes in their morphology. In case of sample strained in air (1st variant) SEM observations reveal ductile fracture (Fig. 4).

Fig. 4. Fracture morphology of WE43 alloy after SSRT (1st variant)

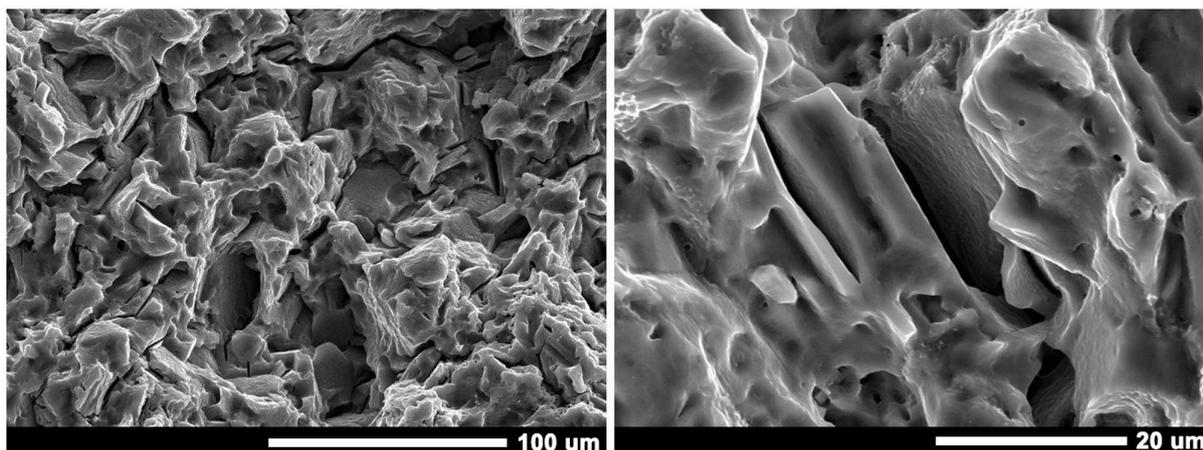
However in case of sample strained during cathodic polarization (3rd variant), fracture morphology changed from ductile to brittle with many micro cracks (Fig. 5).

Fig. 5. Fracture morphology of WE43 alloy after SSRT (3rd variant)

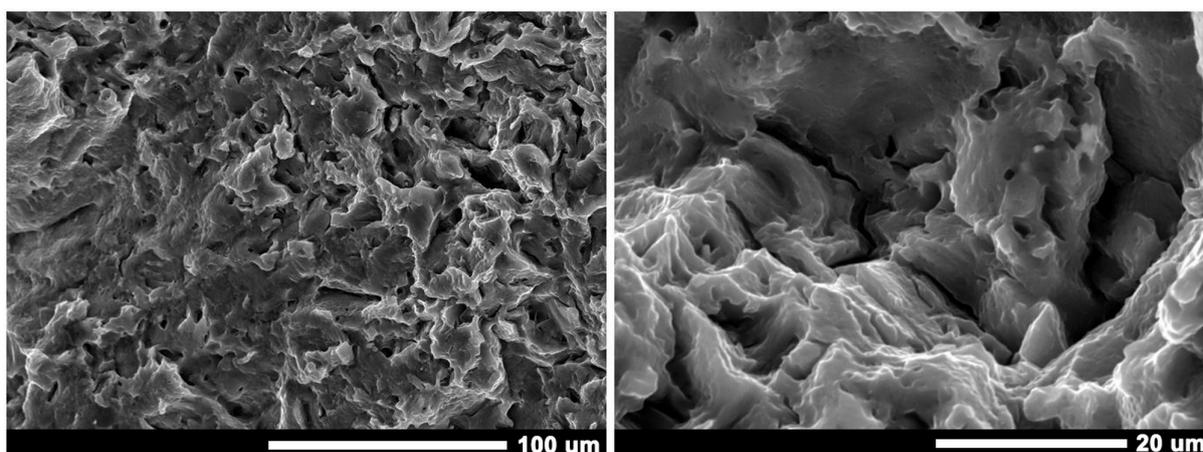
Sample strained in air after hydrogenation (2nd variant) was characterized by complex fracture morphology: the fracture was mainly ductile, but there were some brittle areas with cracks (Fig. 6). However, the number of cracks was much lower in comparison to 3rd variant of SSRT.

Fig. 6. Fracture morphology of WE43 alloy after SSRT (2nd variant)

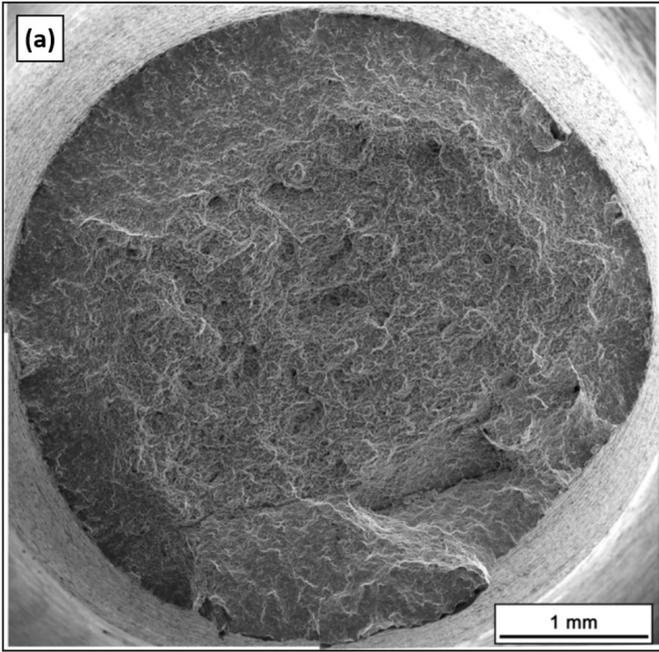
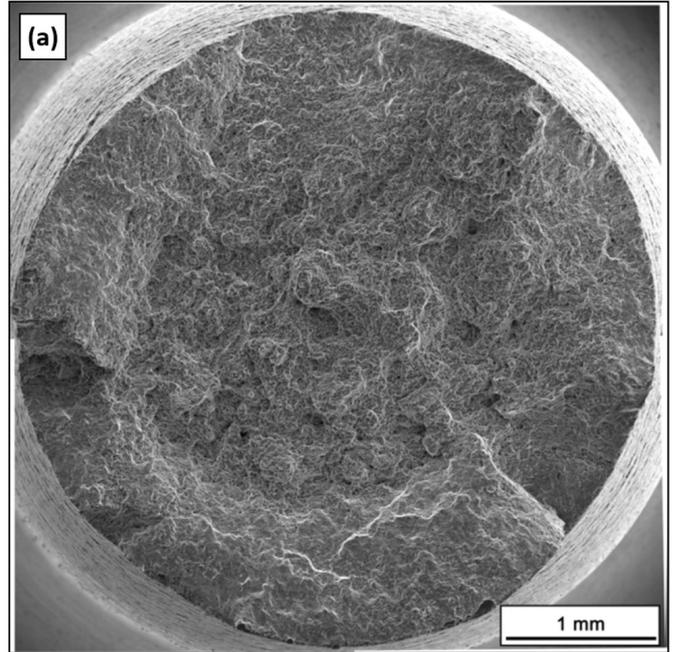
Examination of sample strained in air reveals only few randomly spaced cracks on fracture surface (about 17) – Fig. 7. Maximal size of these cracks was 51 μm in length and 1.6 μm in width. Sample after 3rd variant of SSRT was characterized by the highest number of cracks (3143), but they were non-uniformly spaced on fracture surface. The highest accumulation of cracks was found in the area between the centre and the edge of the sample (Fig. 9). Probably it was caused by the off-centre setting

Fig. 7. Fracture morphology of WE43 alloy after 1st variant of SSRT (a) and binary image of cracks on fracture surface (b)

Binary images of cracks on fracture surfaces (Fig. 7-9) intended for quantitative analysis and their results (Table 2) reveal significant differences between all samples.

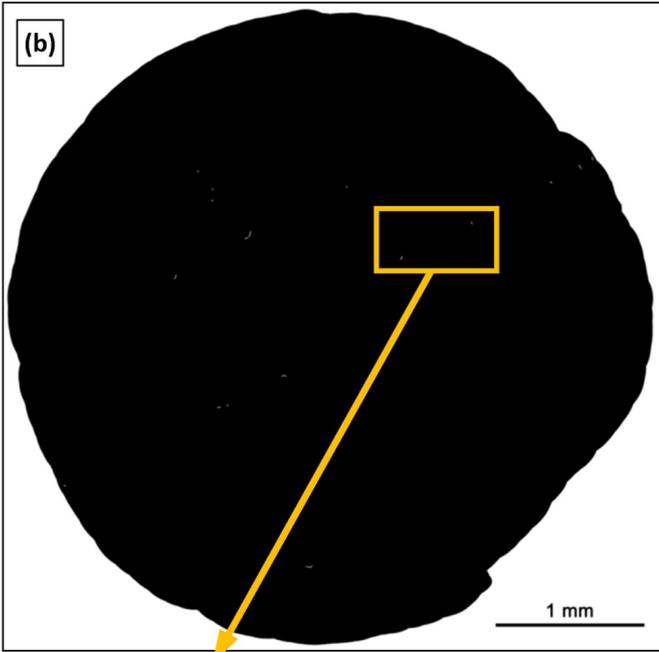
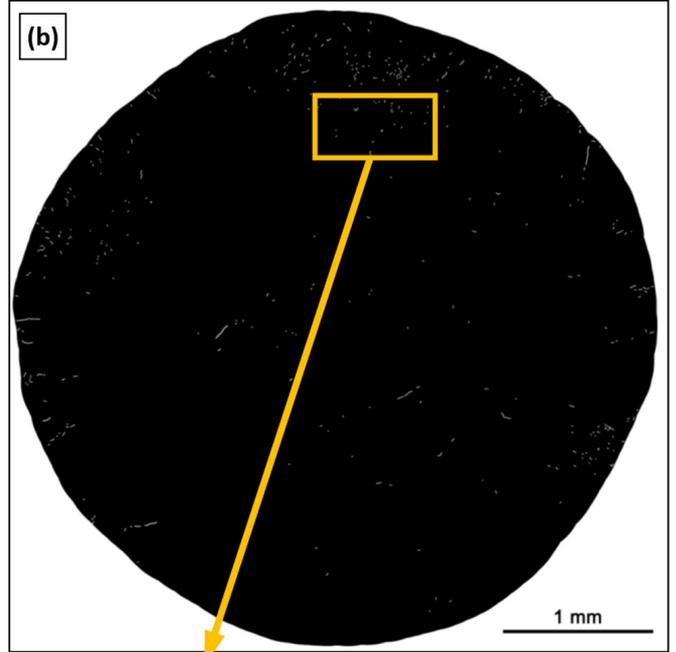
Fig. 8. Fracture morphology of WE43 alloy after 2nd variant of SSRT (a) and binary image of cracks on fracture surface (b)

of tensile bar and cylindrical anode during cathodic polarization. Average length of cracks was similar for all SSRT variants and equal to about 25 μm . The biggest cracks was observed for sample after 3rd variant of SSRT (294 μm in length and 14.7 μm in width). Despite of small differences in mechanical properties between 1st and 2nd variant of SSRT (Table 1), quantitative fractography reveals significant differences (Table 2): there were about 409 cracks (max. length – 178 μm , max. width – 2.5 μm)

on the sample strained after hydrogenation (2nd variant). Cracks were non-uniformly spaced on fracture surface, similar to the fracture after 3rd variant.

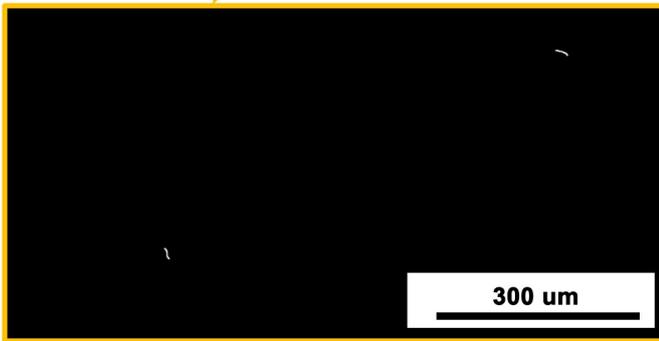
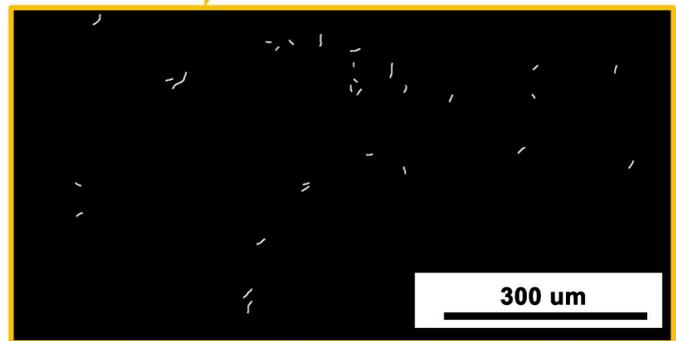
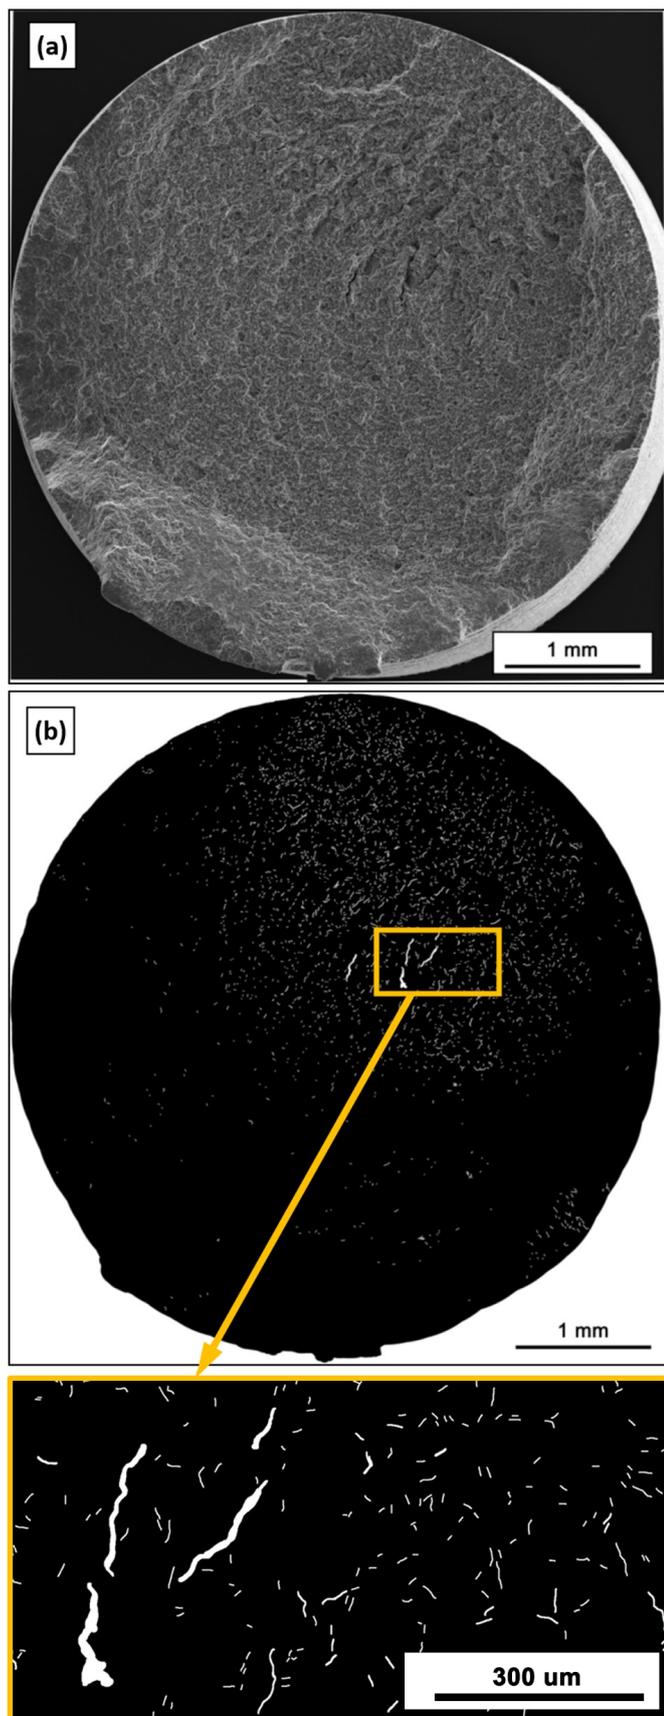
Fig. 9. Fracture morphology of WE43 alloy after 3rd variant of SSRT (a) and binary image of cracks on fracture surface (b)
