EFFECT OF LOCAL STRAIN DISTRIBUTION OF COLD-ROLLED ALLOY 690 ON PRIMARY WATER STRESS CORROSION CRACK GROWTH BEHAVIOR

Keywords: Alloy 690, crack growth, electron backscatter diffraction, local strain distribution, stress corrosion cracking

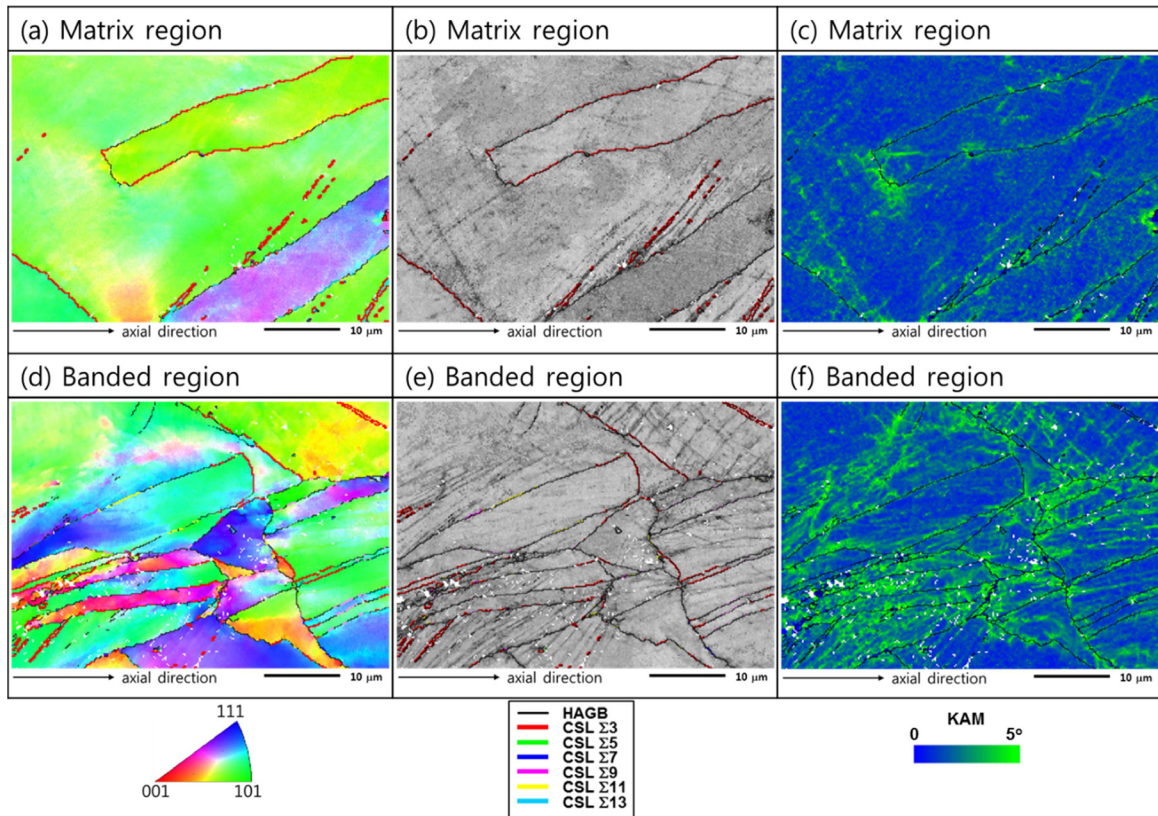
Fig. 1. IPF, PQ and KAM maps obtained from the heterogeneous Alloy 690 cold-rolled at a thickness reduction ratio of 20%; (a) IPF, (b) PQ and (c) KAM map of the matrix region, (d) IPF, (e) PQ and (f) KAM map of the banded region

Fig. 1 gives the IPF, PQ, and KAM maps, measured at a magnification of $2500\times$ from the matrix region of the coarse grains and the banded region of the small grains with intragranular carbides in the heterogeneous Alloy 690 cold-rolled at a thickness reduction of 20% [5]. In an IPF image, showing crystal orientations that are parallel to the normal direction of the observed planes, a non-strained material generally reveals one principal orientation per grain (i.e. one color per grain). The IPF image shown in Fig. 1a reveals that the degree of color gradation increased near grain boundaries (GBs) within a coarse grain in the matrix region. In the PQ image shown in Fig. 1b, the pattern quality was lower (i.e. darker color on the gray scale) near GBs in the matrix region. Those results in IPF and PQ images indicate an increase in the degree of mis-orientation near GBs of coarse grains due to plastic strain by cold-rolling. The local mis-orientation can be more clearly seen in the KAM map shown in Fig. 1c. The local plastic strain was mainly accumulated near GBs of coarse grains in the matrix region.

On the other hand, in the banded region shown in the IPF image of Fig. 1d, the degree of color gradation increased in the grain interior and near GBs as well within a small grain. In the PQ image shown in Fig. 1e, the pattern quality was lower near GBs and along multiple slip bands that appeared in the interior of the small grains. The KAM map in Fig. 1f also revealed plastic strain localization near GBs and along slip bands in the banded region. It should be noted here that the degree of mis-orientation increased remarkably along the slip bands in the interior of the grains and near the GBs in the banded region of the small grains with intragranular carbides, as compared to that in the matrix region of the coarse grains in the heterogeneous Alloy 690 after severe plastic deformation.

Based on the above simple correlation between the KAM value and the plastic strain, the KAM maps shown in Fig. 1c and f can reveal the microscopic heterogeneity of local strain distribu-

tion in the cold-rolled Alloy 690, even though the macroscopic strain is the same. In the matrix region of coarse grains, the plastic strain is primarily concentrated near GBs where dislocations accumulate, while the plastic strain is also localized along slip planes extending into the grain interior in the banded region of small grains possibly owing to intragranular carbides acting as a barrier to dislocation movement [12].

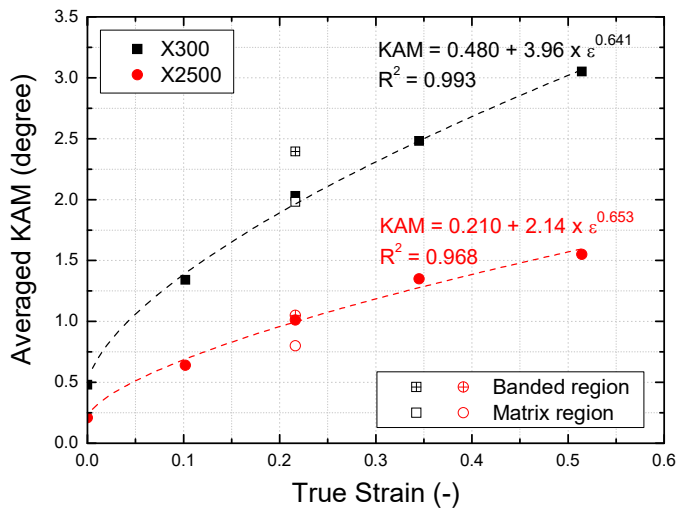
Fig. 2. Plots of the averaged value of KAM as a function of the true strain, measured at two different EBSD magnifications of $300\times$ and $2500\times$

Under these circumstances, in this work a relationship between KAM and the plastic strain was established for local strain analysis. Fig. 2 gives the averaged value of KAM measured from the cold-rolled specimens at two different EBSD magnifications as a function of true strain, simply given by $\epsilon = \ln(t_f/t_i)$, where t_f and t_i are the final and the initial thickness of the specimen in the cold-rolling process [11]. As can be seen in Fig. 2, the average value of KAM revealed a well-defined power law relation

with the true strain or equivalent von Mises strain [12] and was fitted as

$$\text{KAM} = 0.480 + 3.96 \times \varepsilon^{0.641} \text{ at a magnification of } 300\times \quad (1)$$

$$\text{KAM} = 0.210 + 2.14 \times \varepsilon^{0.653} \text{ at a magnification of } 2500\times \quad (2)$$

with goodness-of-fit R^2 values of 0.993 and 0.968, respectively.

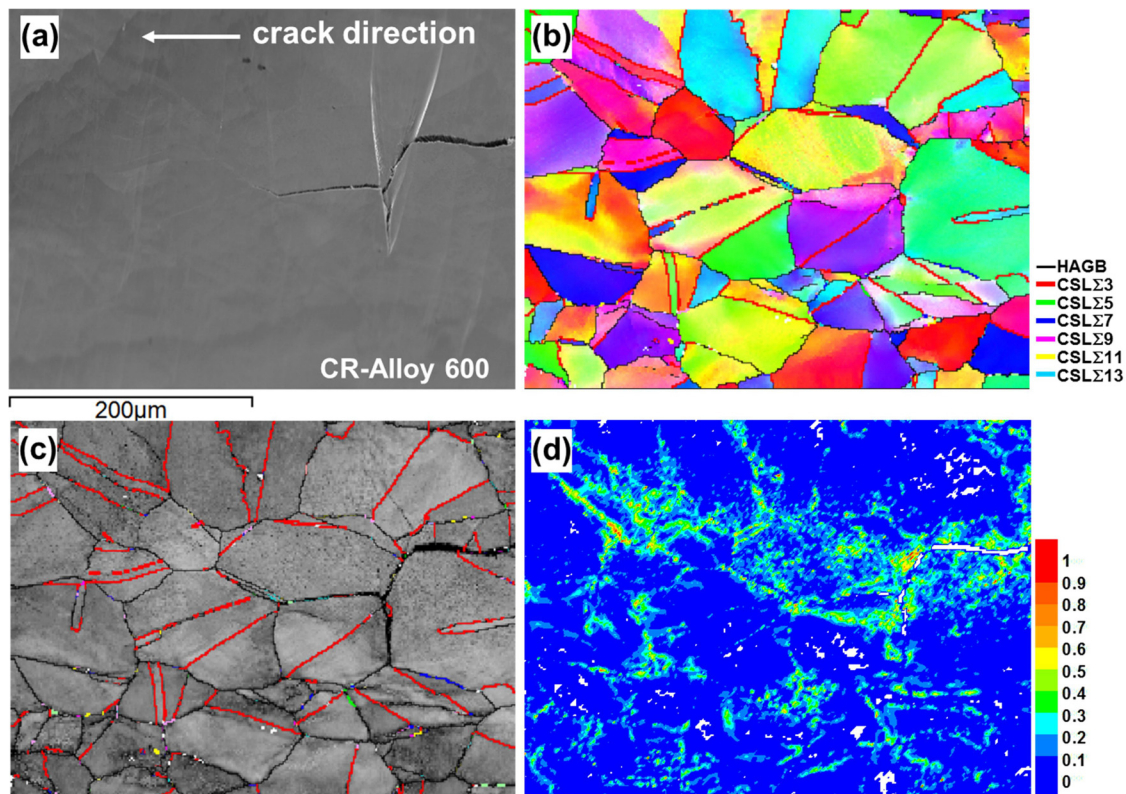
Fig. 3. EBSD results obtained at a magnification of 300 \times from the cross-section of crack in the cold-rolled Alloy 600 after the SCC test in the primary water environment; (a) SEM micrograph of the cross-section around crack tip, (b) IPF, (c) PQ, and (d) local strain distribution map

Fig. 3 shows the EBSD results obtained at a magnification of $300\times$ from the cross-section of PWSCC that occurred in the cold-rolled Alloy 600 during the SCC test in the primary water environment. Fig. 3a provides an SEM micrograph of the cross-section around the crack tip. Fig. 3b and c show the IPF and PQ images, respectively, obtained for the same area as that shown in Fig. 3a; the grain boundary characters were superimposed on the images with different colors as random high angle boundary (HAGB) and various coincidence site lattice (CSL) boundaries. In the cracked area of the IPF image (Fig. 3b), the crystal orientation of the grains adjacent to the crack was extrapolated to characterize the GB type. From the IPF and PQ images, it is obvious that the main crack grew along the HAGBs in IG mode. Extensive examination of the cross-section along the entire cracking path ruled out any crack growth in TG mode or along the CSL boundaries in the cold-rolled Alloy 600. The results

Fig. 3d presents the local strain distribution, estimated from the EBSD-derived KAM data using the calibration curve of KAM vs. true strain given by Eq. 1. Although it is difficult to measure the actual magnitude of the strain from the EBSD patterns, the local strain analysis approach in this work is capable of identifying relative strain distribution within a microstructure with the aid of calibration curves, as discussed in Section 3. Fig. 3d suggests that PWSCC grew in IG mode along HAGBs that were highly strained rather than grain interior; however, the crack did not propagate along the CSL boundaries, even those boundaries that were highly strained by the cold-rolling process.

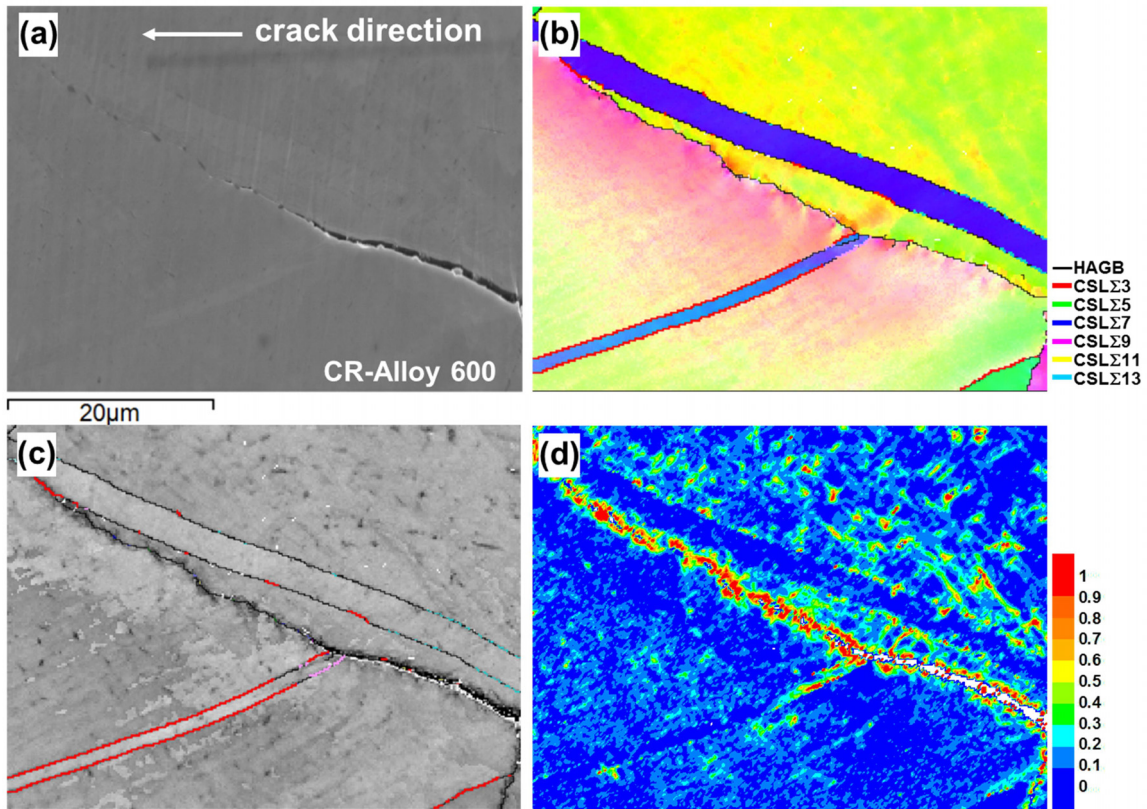
Fig. 4. EBSD results obtained at a magnification of 2500× from the cross-section of crack in the cold-rolled Alloy 600 after the SCC test in the primary water environment; (a) SEM micrograph of the cross-section around crack tip, (b) IPF, (c) PQ, and (d) local strain distribution map

This consistency between the crack path and the local strain distribution can be more clearly visualized in Fig. 4, which was obtained at a magnification of 2500 \times around the crack tip shown in Fig. 3. The local strain distribution map in Fig. 4d was derived from the KAM map using the calibration curve given by Eq. 2. From those figures, it was confirmed that the PWSCC of the cold-rolled Alloy 600 tends to grow along the highly strained HAGB.

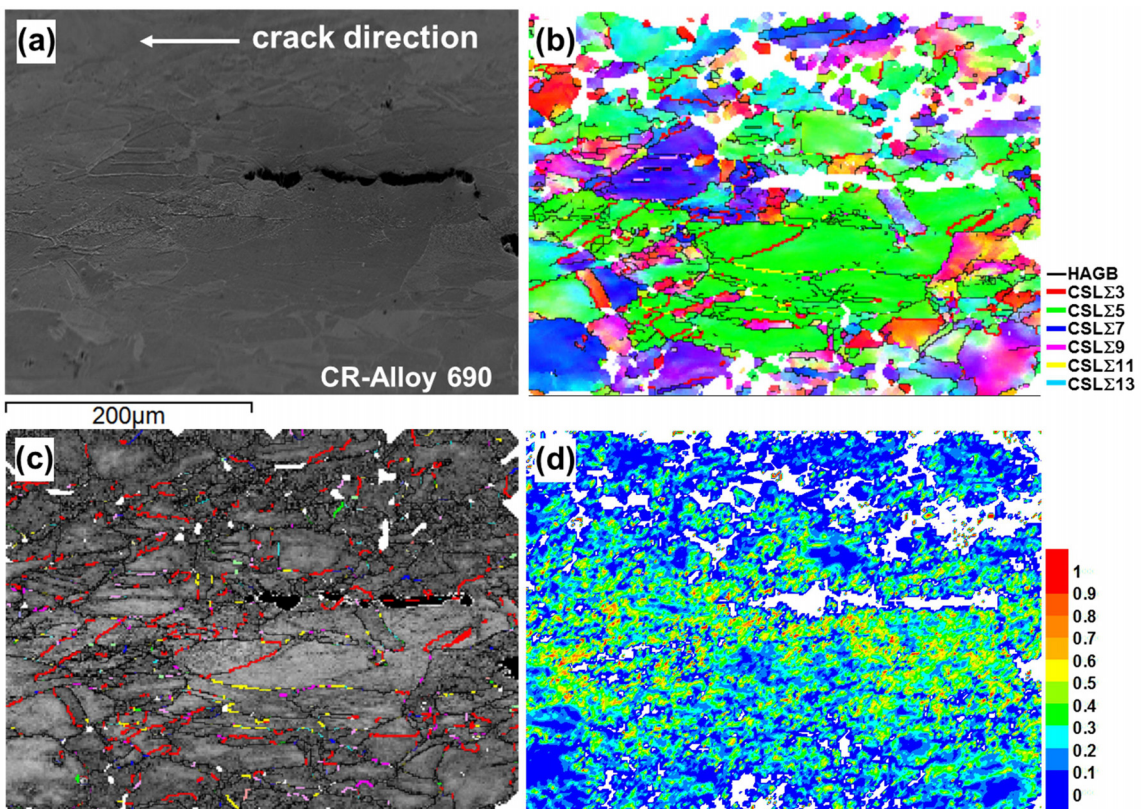
Fig. 5. EBSD results obtained at a magnification of 300× from the cross-section of crack in the cold-rolled Alloy 690 after the SCC test in the primary water environment; (a) SEM micrograph of the cross-section around crack tip, (b) IPF, (c) PQ, and (d) local strain distribution map

Fig. 5 gives EBSD results obtained at a magnification of 300 \times from the cold-rolled Alloy 690 after the SCC test in the primary water environment. The SEM, IPF, and PQ images in Fig. 5a through c reveal that the PWSCC of the cold-rolled Alloy 690 with heterogeneous microstructure propagated in TG mode near the banded region of small grains with intragranular carbides. Fig. 5d shows the local strain distribution map, estimated from the

KAM data; however, the image quality is slightly worse than the image quality obtained from the cold-rolled Alloy 600 shown in Fig. 3d, possibly due to the complex heterogeneity in the highly strained microstructure of the cold-rolled Alloy 690. Nevertheless, it seems to be reasonable to admit that the PWSCC of the cold-rolled Alloy 690 propagated in TG mode near the highly strained area, which partially corresponds to the banded region, in a direction perpendicular to the maximum principal stress applied during the SCC test. The crack growth behavior is less dependent on the GB characters than it is on the stress/strain factor.

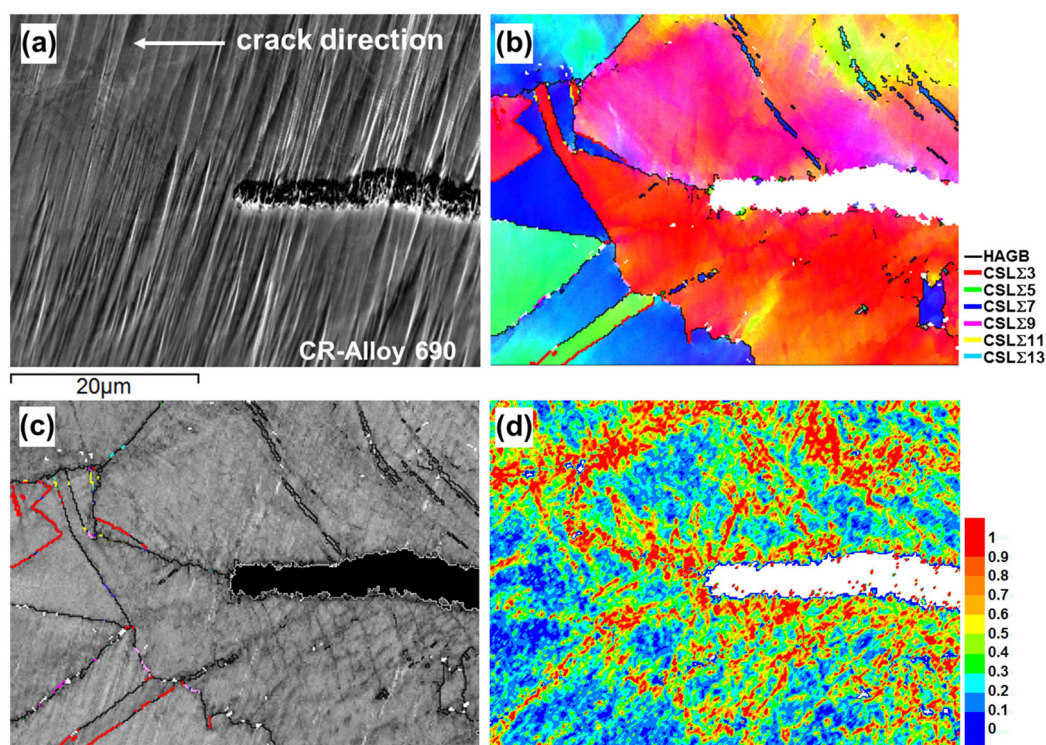
Fig. 6. EBSD results obtained at a magnification of 2500 \times from the cross-section of crack in the cold-rolled Alloy 690 after the SCC test in the primary water environment; (a) SEM micrograph of the cross-section around crack tip, (b) IPF, (c) PQ, and (d) local strain distribution map

When the crack tip encountered the highly strained HAGBs in the matrix region of the cold-rolled Alloy 690, cracking occurred along the most susceptible path to SCC, just as it did for the cold-rolled Alloy 600, as shown in Fig. 6. For the crack propagated in IG mode, EBSD results were obtained around the crack tip at a magnification of 2500 \times for the cold-rolled Alloy 690. It is clear that cracking occurred along the highly strained HAGBs.
