## INFLUENCE OF THE REPETITIVE CORRUGATION ON THE MECHANISM OCCURING DURING PLASTIC DEFORMATION OF CuSn6 ALLOY

This paper presents the research results of CuSn6 alloy strip at semi-hard state, plastically deformed in the process of repetitive corrugation. The influence of process parameters on the mechanical properties and structure of examined alloy were investigated. Examination in high-resolution transmission electron microscopy (HRTEM) confirmed the impact of the repetitive corrugation to obtain the nano-scale structures. It has been found, that the application of repetitive corrugation increases the tensile strength ( $R_m$ ), yield strength ( $R_{p0.2}$ ) and elastic limit ( $R_{p0.05}$ ) of CuSn6 alloy strips. In the present work it has been confirmed that the repetitive corrugation process is a more efficient method for structure and mechanical properties modification of commercial CuSn6 alloy strip (semi-hard) as compared with the classic rolling process.

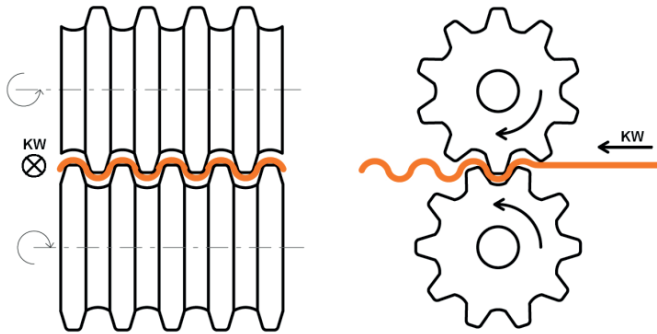
Fig. 1. Layout of bending rolls

a direction transverse to the rolling direction and a pair of bending rolls for deformation of strip in the direction of rolling (Fig. 1)

The strips were processed on an alternating forming of repetitive corrugation in the rolling direction and cross direction. Tapes was rotating an  $180^\circ$  after each cycles. Distinct settings of bending rolls pressure were applied for each direction of corrugation, to perform as much as possible corrugation cycles. Selected pressure parameters allowed for performing a 35 cycles. The alloy strips, after the last corrugation cycle, were subjected to straightening by classic rolling. Repetitive corrugation processes were performed at room temperature.

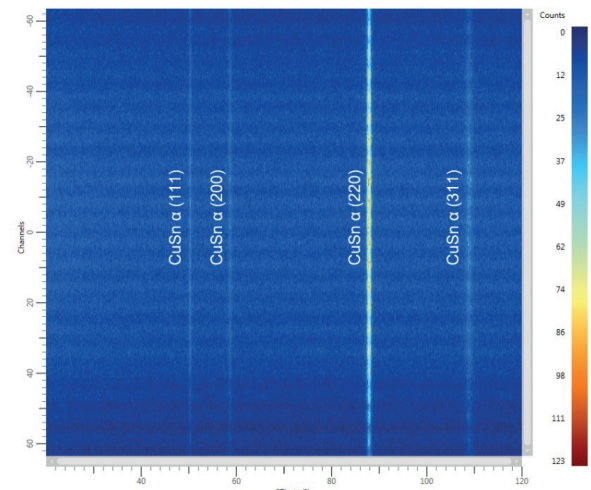
Fig. 2. Two-dimensional X-ray diffraction pattern of CuSn6 strip after repetitive corrugation process (detector PIXcel 3D)

The X-ray diffraction analysis carried out using the two-dimensional detector mode (Pixel 3D), allowed to obtain information about the structure and extent of plastic deformation of the crystal lattice of investigated CuSn6 strips. The diffraction lines of crystal planes with Miller indices (111), (200), (220) and (311), characteristic for the structure of the CuSn- $\alpha$  solid solution, were observed on recorded two-dimensional diffraction pattern (Fig. 2). For the strongest diffraction line (220), spots with a distinct blurring was observed the. This is the result of structure deformation consisting in the bending or twisting of the lattice of individual crystallites.

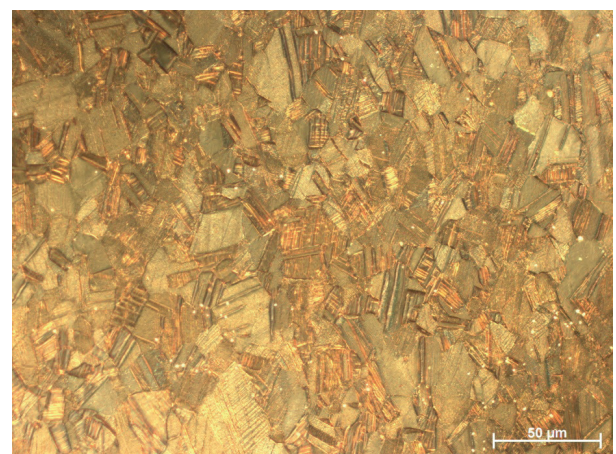
Fig. 3. Structure of CuSn6 alloy after repetitive corrugation process (magnification 500x, polarized light, optical microscope)

The microstructure of CuSn6 strip after repetitive corrugation, observed in polarized light technique and Nomarski differential interference contrast (DIC) is shown in Fig. 3 and 4. It was found that the structure of analyzed strip consists of grains of the solid solution  $\alpha$  with annealing twins. Analyzed structures of CuSn6 strips after plastic deformation by using repetitive corrugation process are characterized by larger number of crossing slippage systems lines visible within the interior of grains. It can be assumed that unprivileged distribution of slip bands in the structure of the strip after repetitive corrugation, are the result of strengthening and block slip systems most privileged relative to the rolling direction and the gradual launching new slip systems. Another possible factor causing the increase in the number of active crystal planes involved in the mechanism of slip is critical shear stress in different directions, being the result of a complex deformation process.

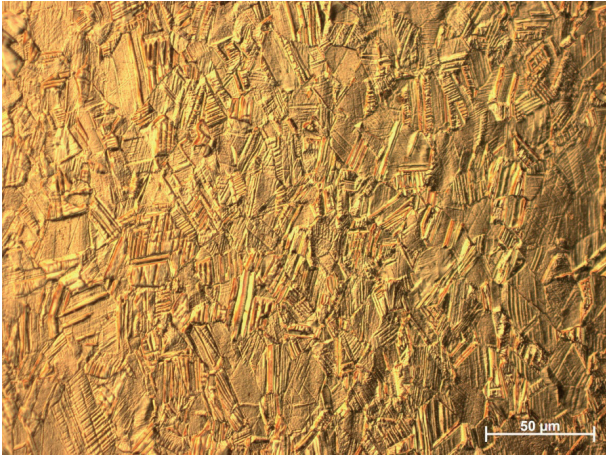
Fig. 4. Structure of CuSn6 alloy after repetitive corrugation process (magnification 500x, Nomarski differential interference contrast, optical microscope)

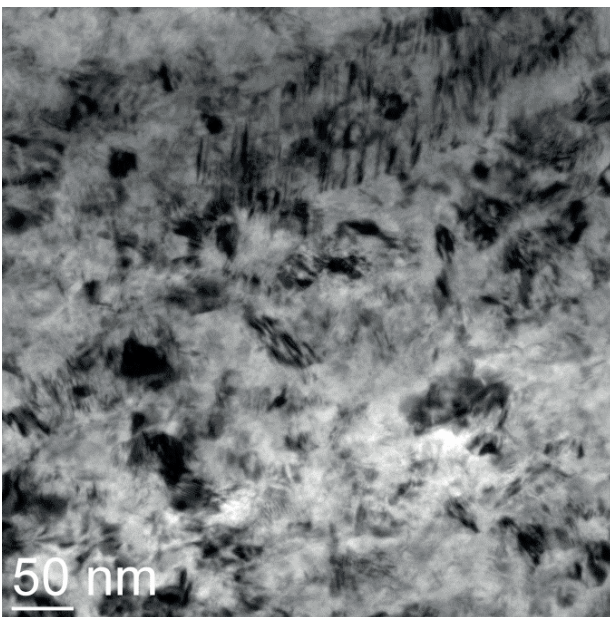
Fig. 5. Structure of CuSn6 alloy after repetitive corrugation process (TEM bright field mode, high-resolution transmission electron microscopy) [10]

The results of the high-resolution transmission electron microscope are shown in Figures 5 ÷ 9. The structure of the strip after repetitive corrugation process (Fig. 5 and 6), consists of a well-developed dislocation sub-structure. The dislocation cells are characterized in size from 10 to 100 nm, and low-angle boundaries, which in some case they evolve, by interacting with the moving dislocations and increasing of disorientation angle. This can be observe (Fig. 7) as a higher contrast of the boundaries, which is the result of accumulation and decreasing the distance between dislocations with the increasing of disorientation angle. The high-energy grain boundaries, formed in this way, are an obstacle to moving dislocations, and are a source of new dislocations. In the analysed structure of the CuSn- $\alpha$  solid solution, there are numerous nanometric deformation twins (Fig. 8), and the slip lines in several independent slip systems (Fig. 9).

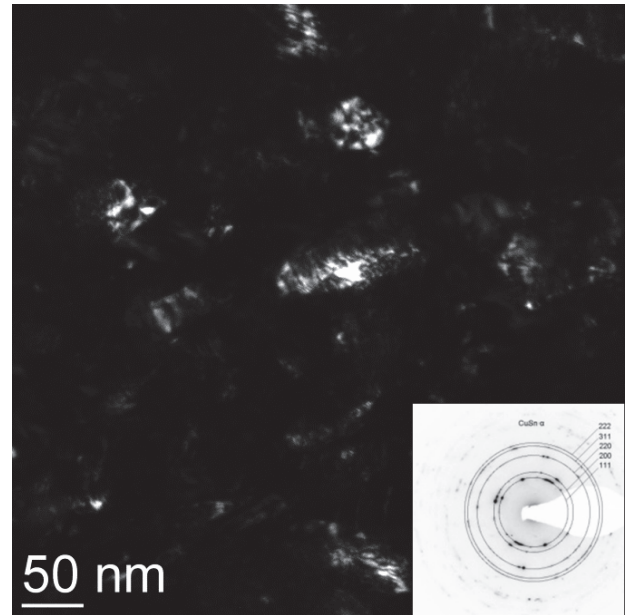
Fig. 6. Structure of CuSn6 alloy after repetitive corrugation process (TEM dark field mode, high-resolution transmission electron microscopy) [10]

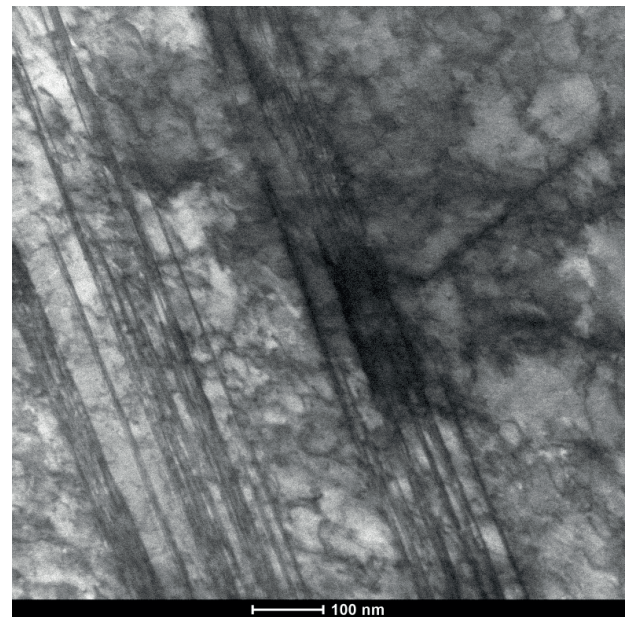
Fig. 7. Structure of CuSn6 alloy after repetitive corrugation process (STEM mode, high-resolution transmission electron microscopy) [10]

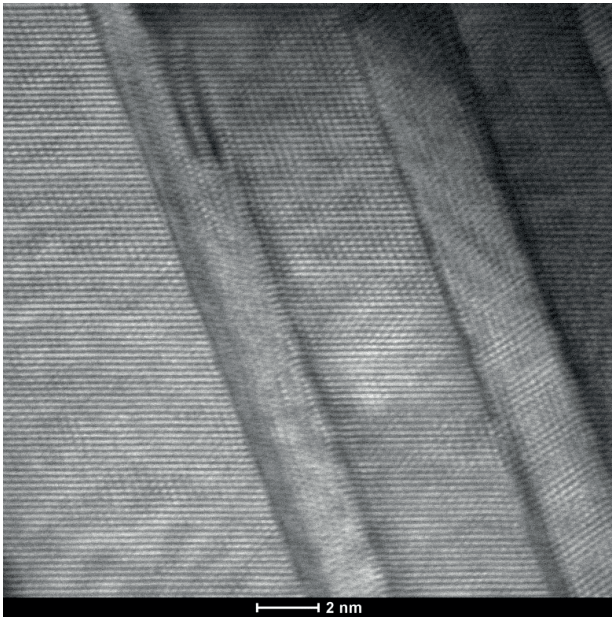
Fig. 8. Structure of CuSn6 alloy after repetitive corrugation process (STEM mode, high-resolution transmission electron microscopy) [10]

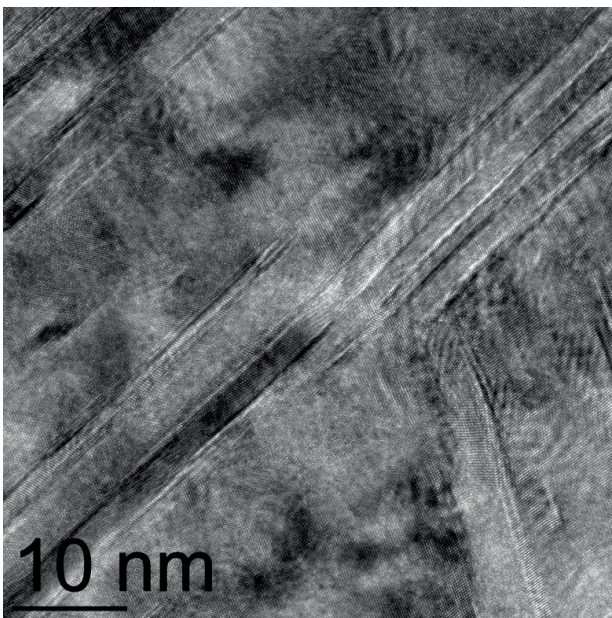
Fig. 9. Structure of CuSn6 alloy after repetitive corrugation process (HRTEM mode, high-resolution transmission electron microscopy) [10]
