Microstructural conditions of the improvement of properties of Mg construction alloys

Piotr Drzymała

**Institute of Metallurgy and Materials Science
Polish Academy of Sciences**

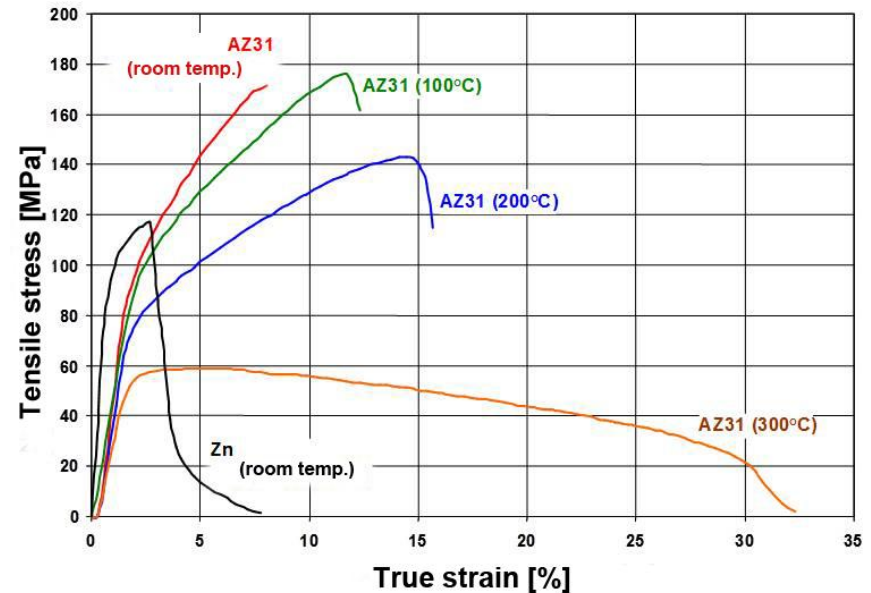
Fig 1. Nominal tensile stress-strain curves for Mg-AZ31 alloy samples tested at various temperatures (room to 300°C with rate of $16 \cdot 10^{-3} \text{ s}^{-1}$ (Bonarski J, Pospiech J, 2010)

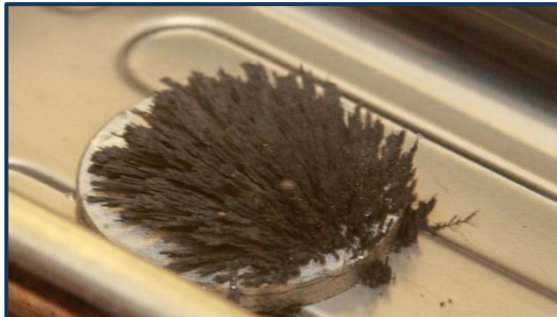
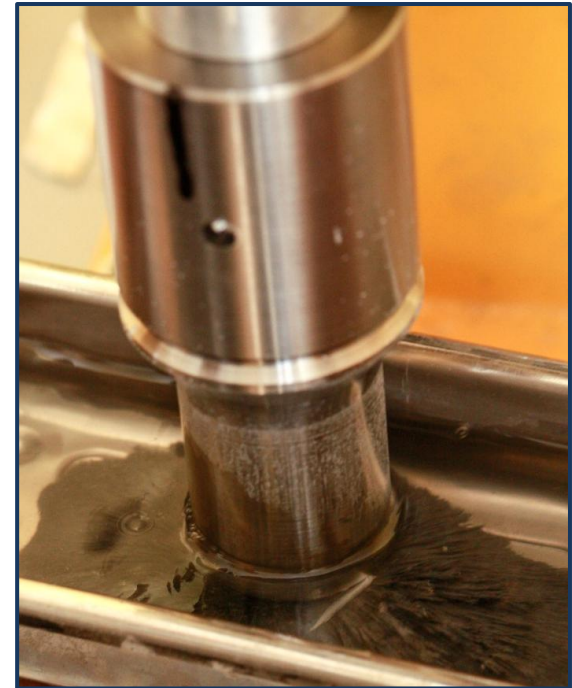
- Attempts to use ultrasounds during tensile test in order to increase plastic deformation were unsuccessful
- In the new approach we focused on modification of samples structure by ultrasonic treatment
- Wrought AZ31 and AZ91 samples were put into dish filled with different types of suspensions

- The energy of ultrasonic waves introduced rapid changes in the pressure of the liquid in which the samples were immersed

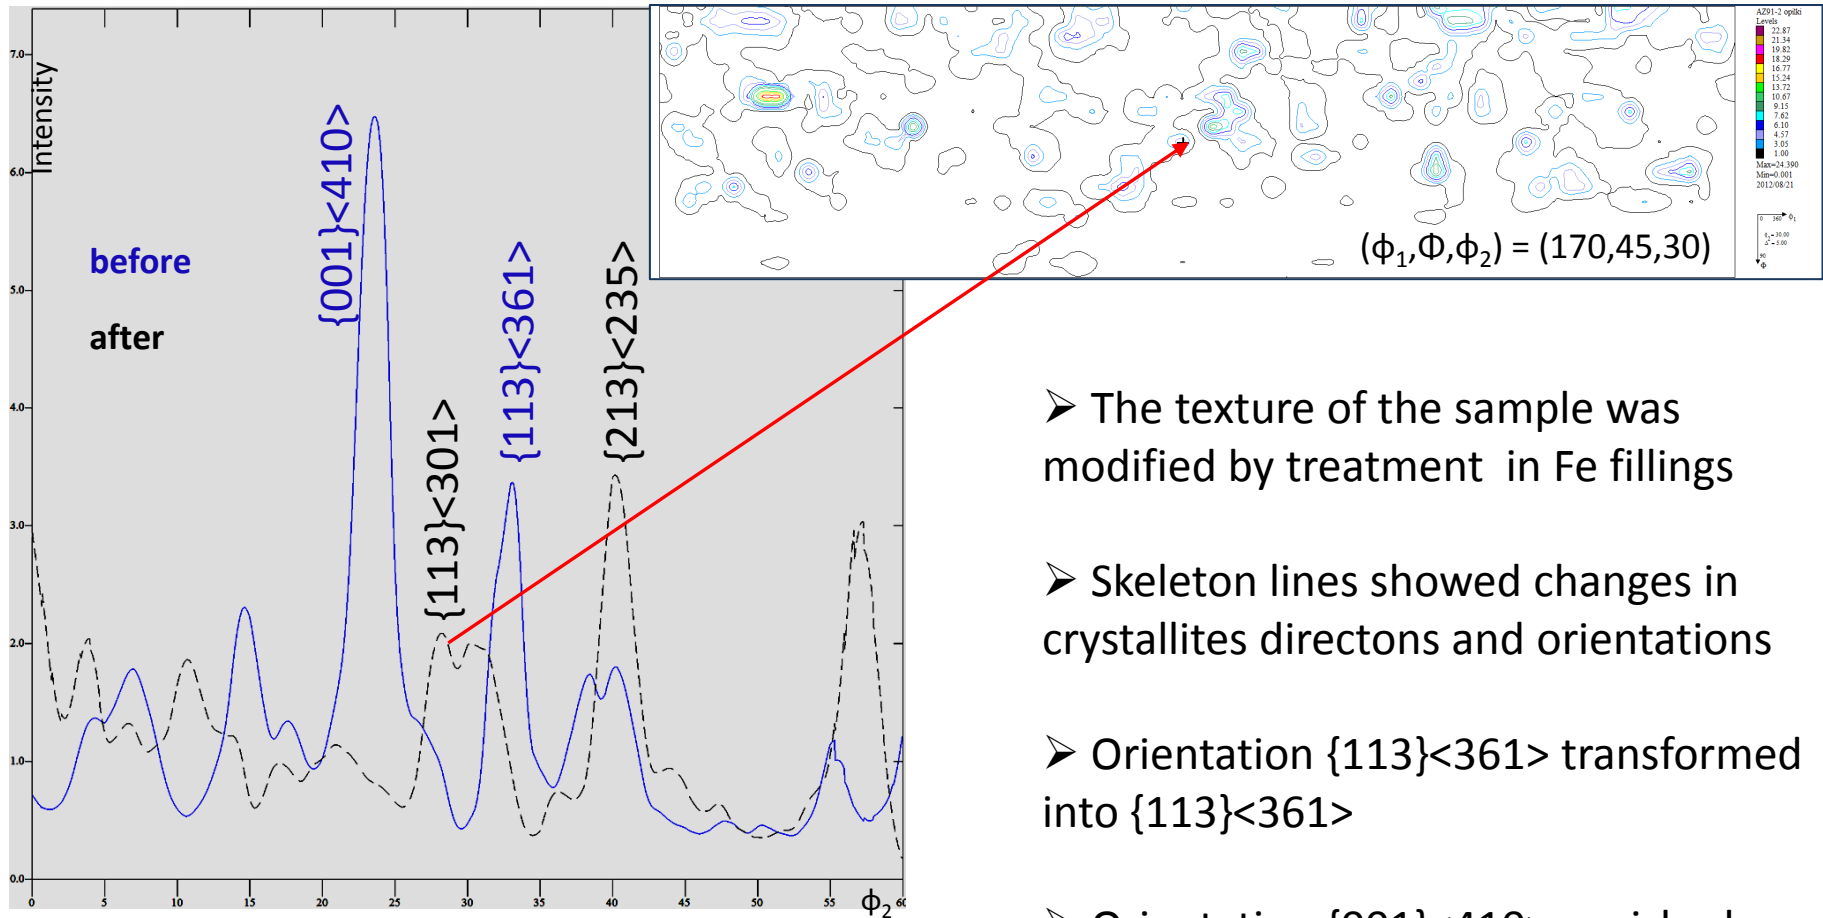
- The texture of the sample was modified by treatment in Fe fillings
- Skeleton lines showed changes in crystallites directions and orientations
- Orientation $\{113\}\langle 361\rangle$ transformed into $\{113\}\langle 301\rangle$
- Orientation $\{001\}\langle 410\rangle$ vanished

AZ91 ultrasonic treated in couplant of iron fillings

- Significant changes in texture were achieved for the sample modified by treatment in Fe fillings
- Ultrasonic treatment had no effect on mechanical properties and microstructure
- In spite of several attempts of alloying magnesium with phosphorus, only trace amount of phosphorus was found in solid solution
- Metal sample reflectivity was changed by introducing local microstructural defects, which affected electron density

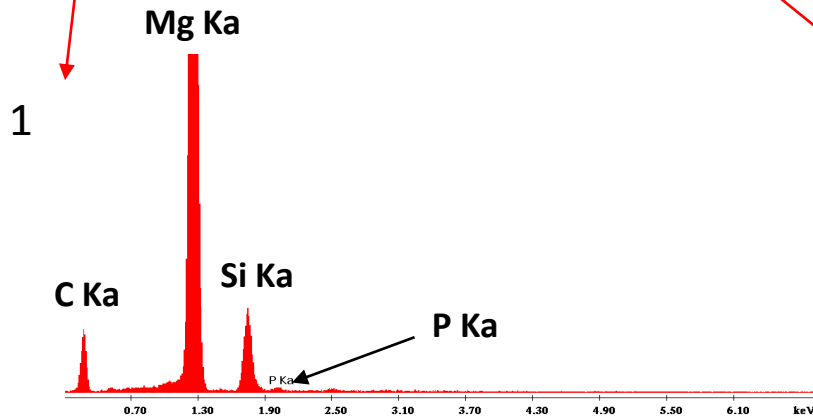
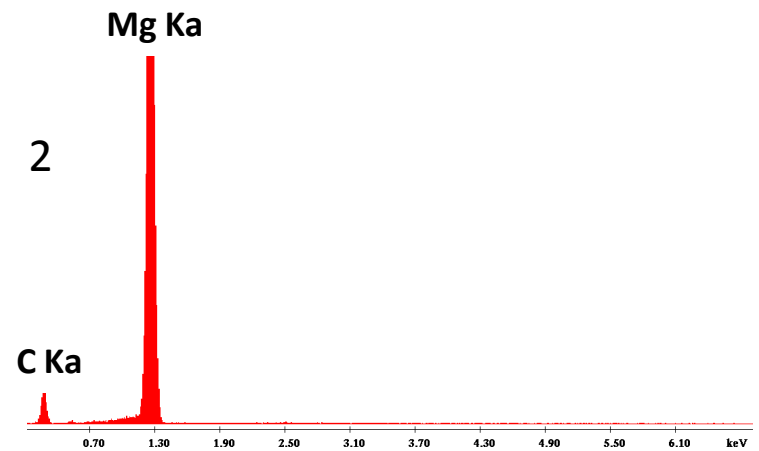
- Mg tubes filled with red phosphorus (10 w%) were melted in crucible in protective atmosphere
- Sample examination by SEM revealed white precipitations of Si in homogenous phase of Mg
- Also trace amount of P inside white precipitations was found

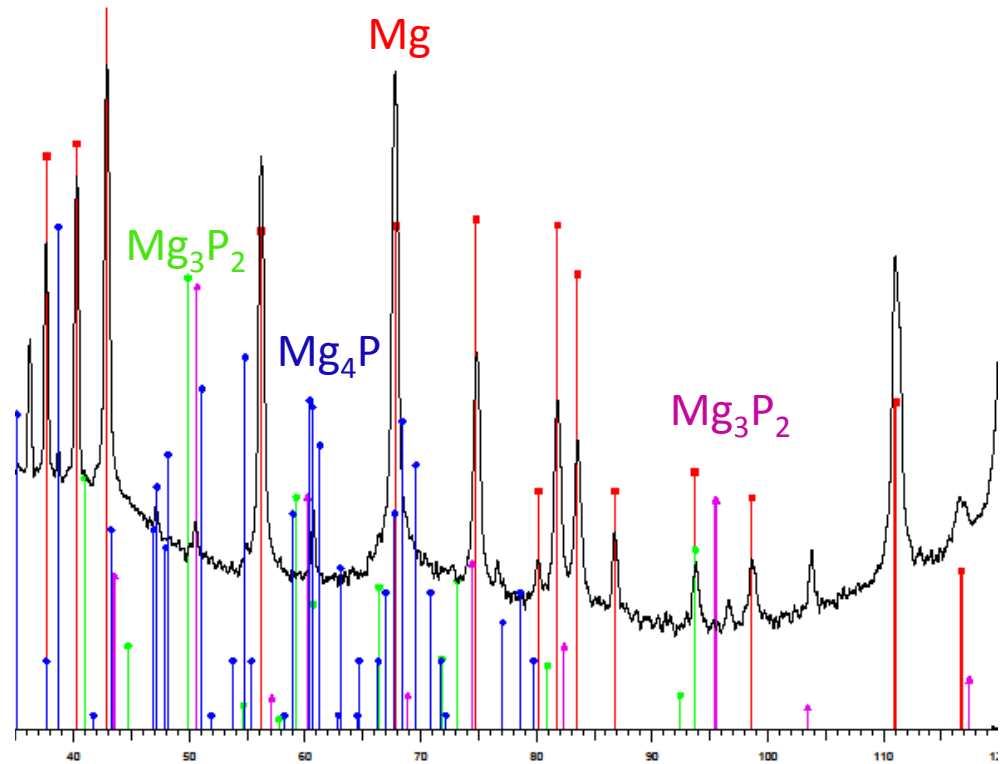
[wt.%]	[at.%]	(1 Sigma), %
Mg 12 K-series	99.97	99.99	0.74
Fe 26 K-series	0.01	0.00	0.00

➤ Spectral analysis proved that solubility of P in Mg is negligible

➤ Phase analysis of Mg10P samples does not confirm presence of magnesium-phosphorus phases

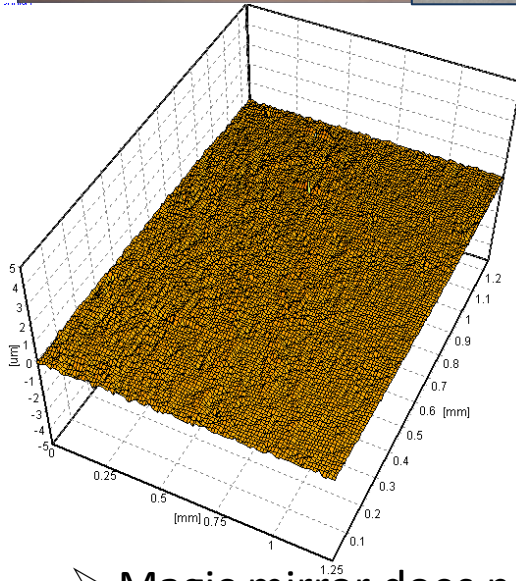
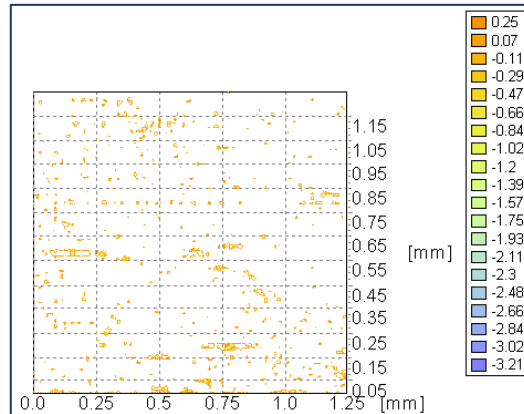
- Magic mirror does not work that way, which was confirmed by analysis of topographic image

- Neither is the image hidden in texture, we expect that it depends on changes in electron density introduced in manufacturing process

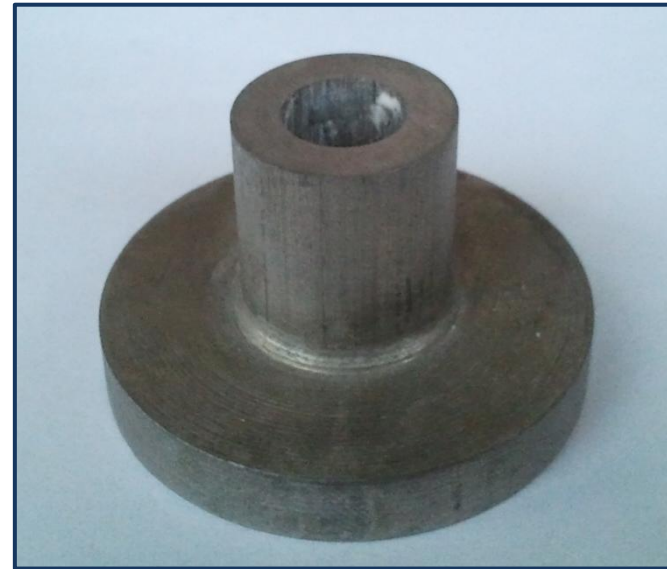
Mg-AZ91 hot extruded tube. The material discontinuities, microstructural defects (porosity, leakage) have not been eliminated due to lack of plastic deformation

- In spite of a few successful attempts at forming in elevated temperature described in the literature, cast alloys still do not have sufficient mechanical properties
- For this reason diecasting and pressing of Mg alloys is not applicable to advanced constructions in aircraft and automotive industry
- Porosity occurs in Mg alloys products manufactured by commonly used cast methods
