ELECTROPLASTIC EFFECT OF HIGH MANGANESE AUSTENITIC STEEL

The article presents the results of the investigations performed on high manganese austenitic steel which underwent the test of uniaxial tension, with the application of electric current impulses. The application of low voltage impulse alternating current of high intensity during the plastic deformation of the examined steel caused the occurrence of the electroplastic effect, which changed the shape of the stress-strain curve. A drop of flow stress and elongation of the tested material was observed in the case of the application of electric current impulses, in respect of the material stretched without such impulses and stretched at an elevated temperature. The analysis of the morphology of the fractures showed differences between the samples tested under the particular conditions. An analysis of the alloy's microstructure was also performed under different conditions. The application of electric current impulses can have a significant influence on the reduction of the forces in the plastic forming processes for this type of steel.

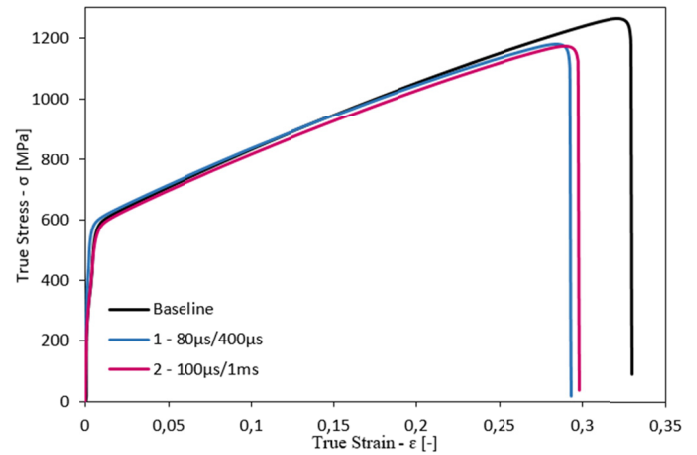
As it has been demonstrated in Figure 3, the application of very short impulses caused a slight drop of stress and a reduction of elongation. With the increase of the impulse length, the drop of stress and the elongation reduction were increasing (Fig. 4). At the same time, an increase of the current density as well as increase of the tested material's temperature was observed – Table 3.

Fig. 3. True stress-strain curves without and with the application of electric current impulses

A comparison of the material's stress-strain curves, both in the case of the application of electric current impulses and without it, at ambient temperature, has been shown in Figs. 3-5. Due to a large number of lines and for better readability, the obtained data have been divided into three groups.

The curves in Figure 6 and 7 show the differences between the tests made with the application of the electric current and their counterparts made at elevated temperatures. Curves no. 1 and 2 should be compared with the baseline (Fig. 3),
